City of Ann Arbor MRF Audit

Company/Dept.: CP MFG / Customer Service		Title: System Audit		Document Number: Audit

Author: M. Augustyn-Morales	Date: 2/9/2017	Rev 1

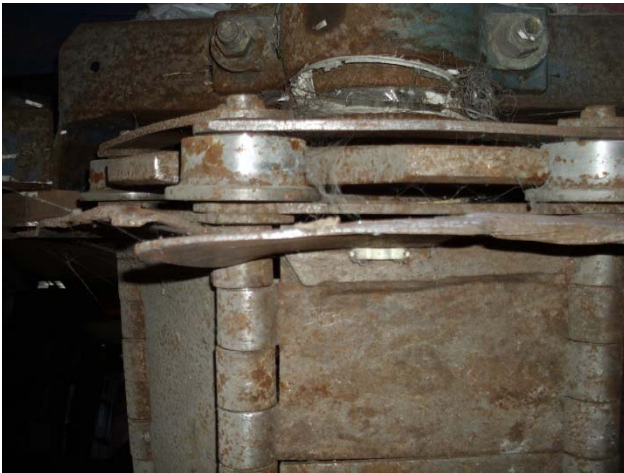
Picture shows damaged side wings on belt.

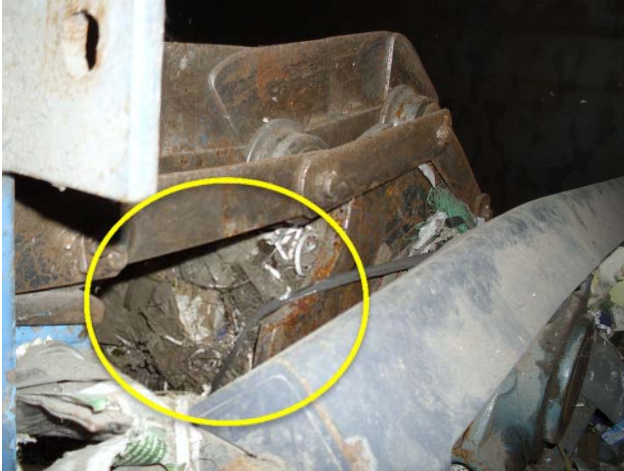
Shaft is wrapped inside of belt.

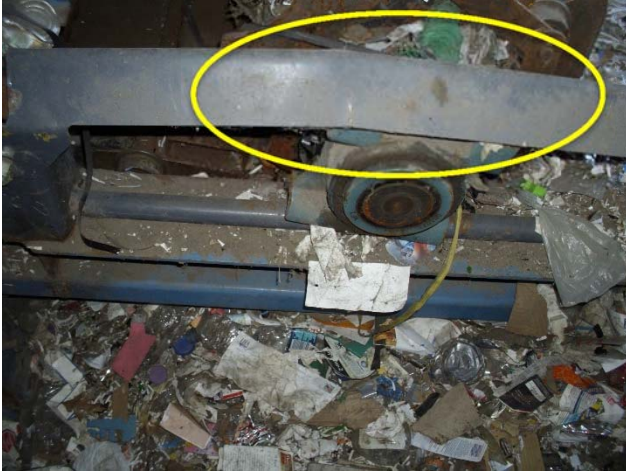
Take up is bent. Shaft is wrapped.

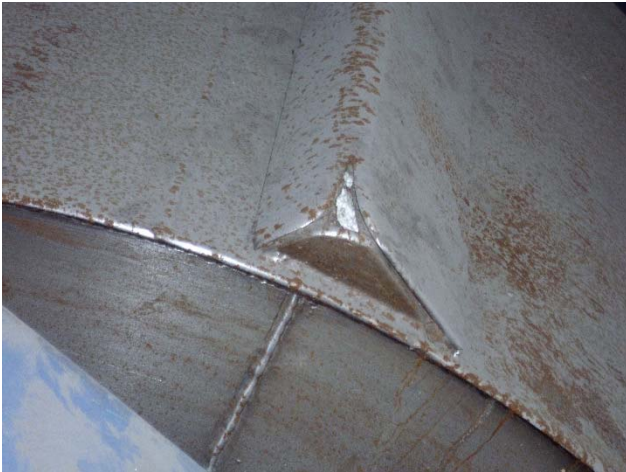
Cleats need to be replaced.

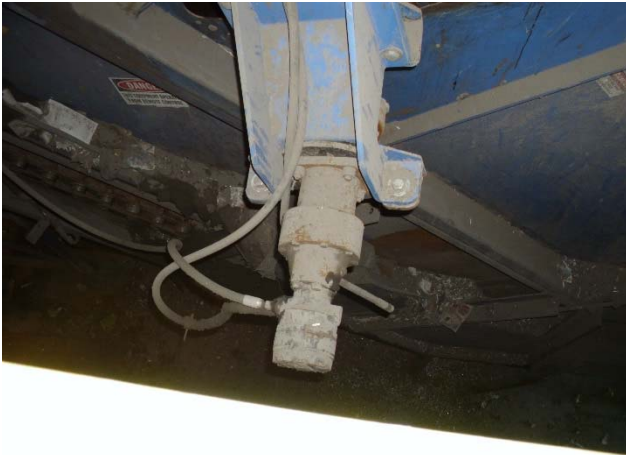
Hydraulic Lines needs to be replaced and/or fixed.

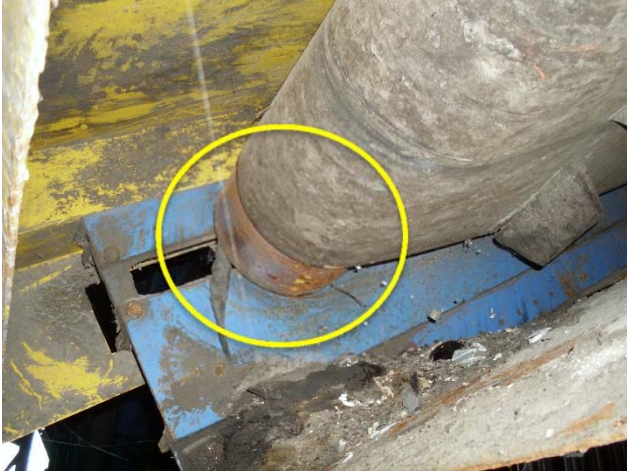
Belt tracking is off.

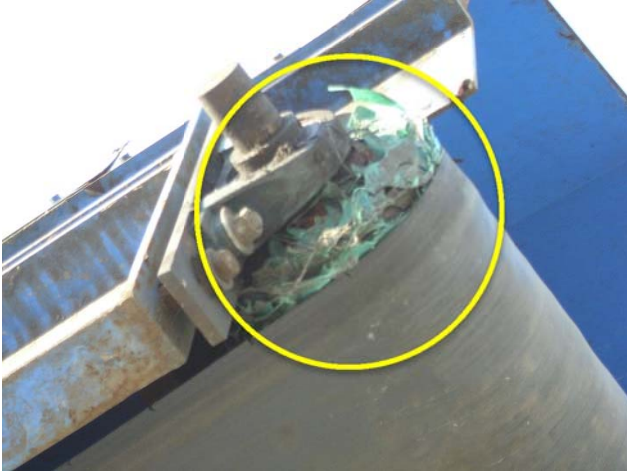
Pulley is wrapped.

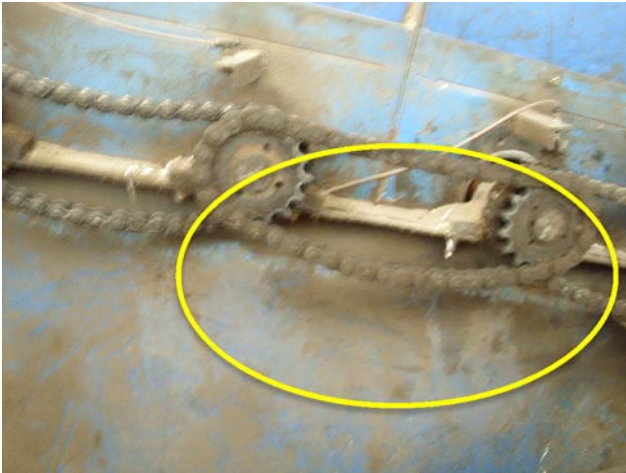
Chains need to be replaced.

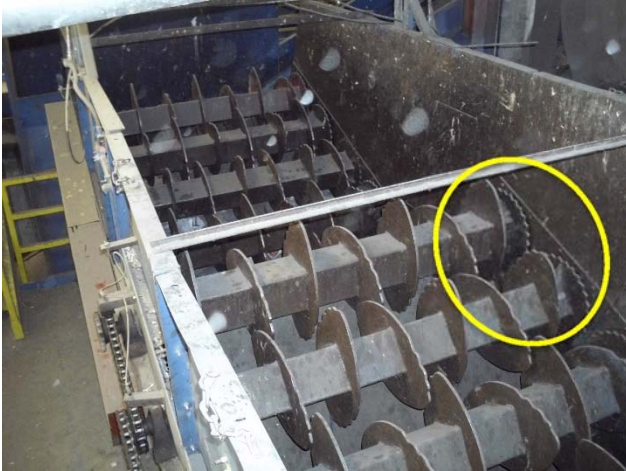
Rotors need to be clocked at 90 degrees.

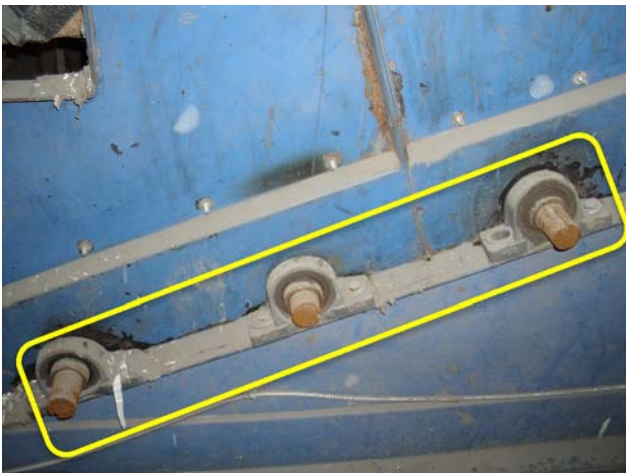
Shafts should be better aligned to normalize disk spacing.

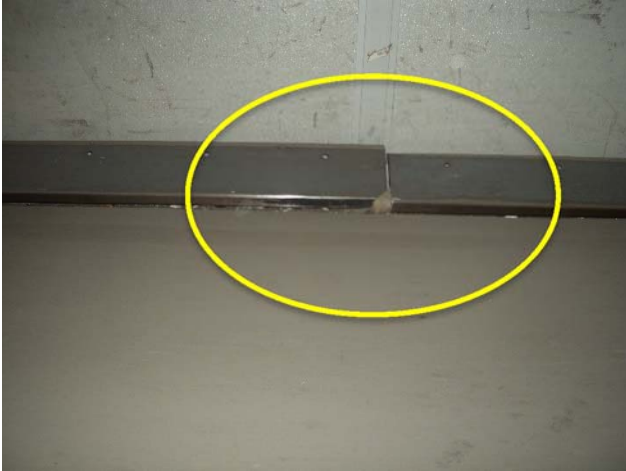
Guarding needs to be replaced.

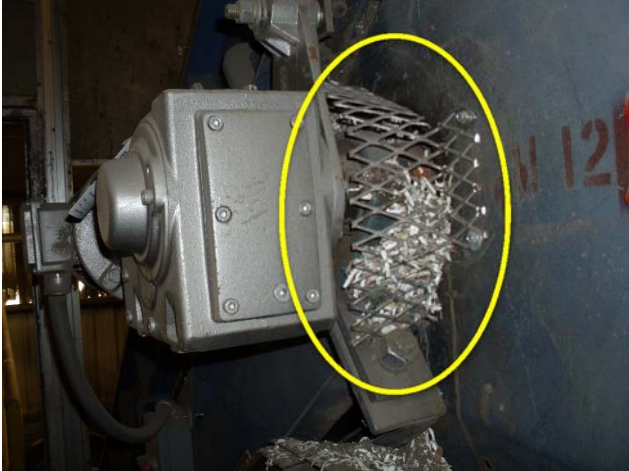
Guarding needs to be replaced.

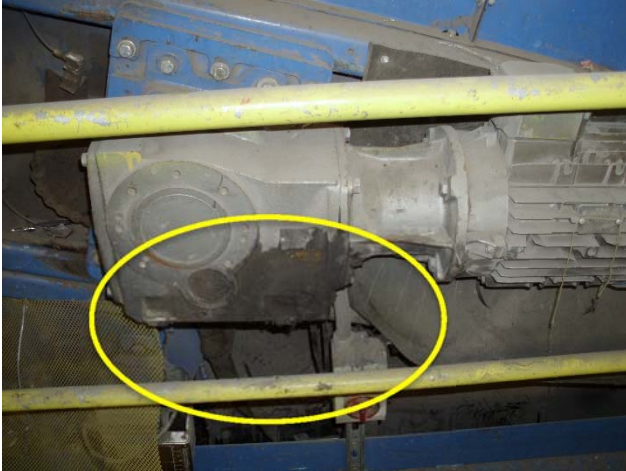
Gearboxes on all decks are leaking and needs to be replaced.

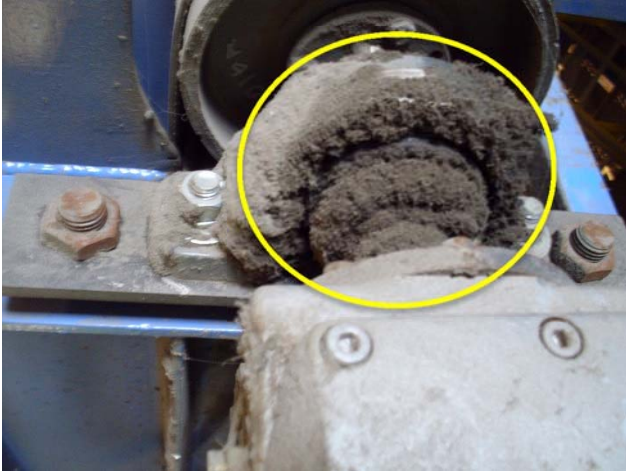
Bearings are worn and needs to be replaced.

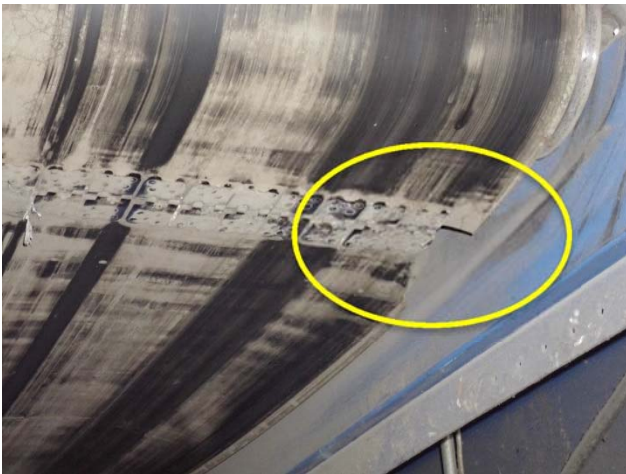
Belt and lacing are torn and needs to be replaced.

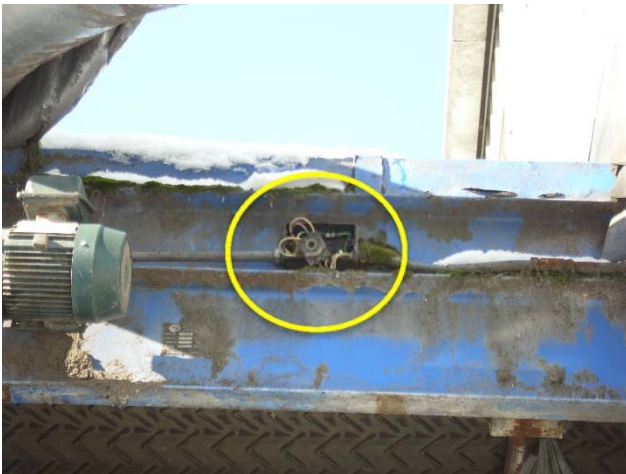
Disconnect switch is missing.

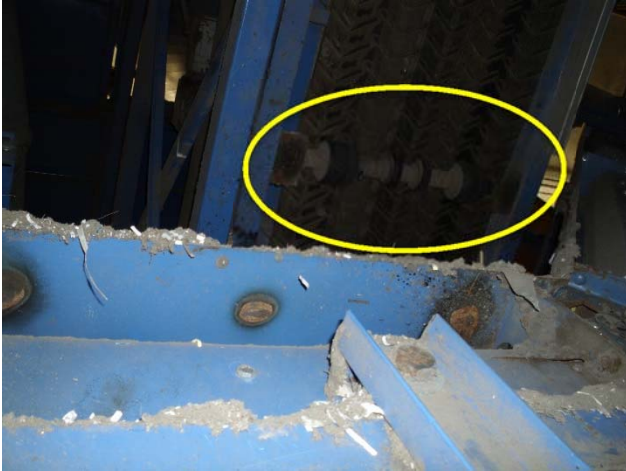
Return rollers are worn and need to be replaced.

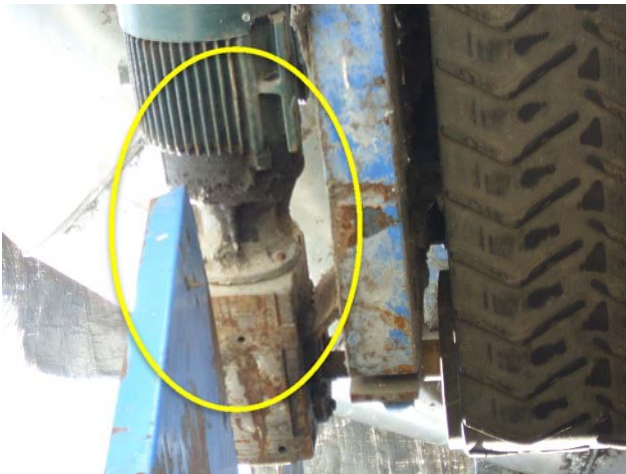
Gearmotor is leaking and needs to be replaced.

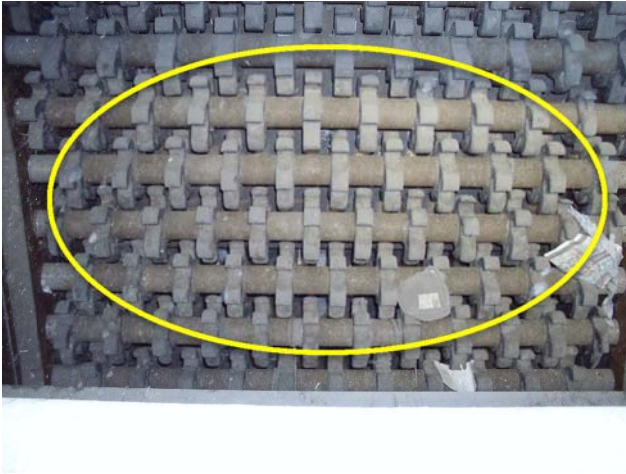
Discs are worn, full deck replacement needed.

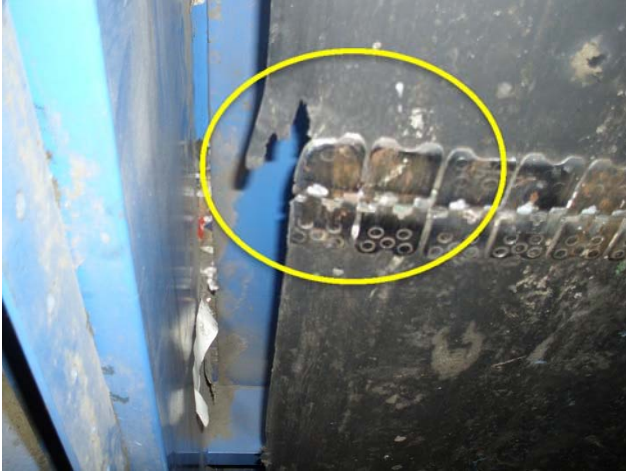
Belt is torn, laced improperly. Replacement recommended.

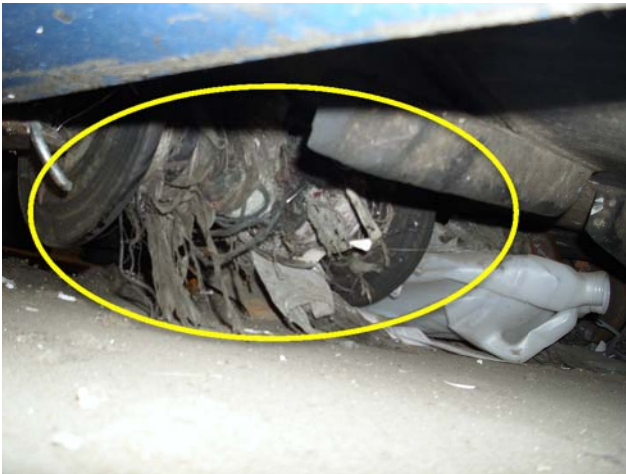
Return rollers need to be replaced. Some return rollers are missing/omitted.

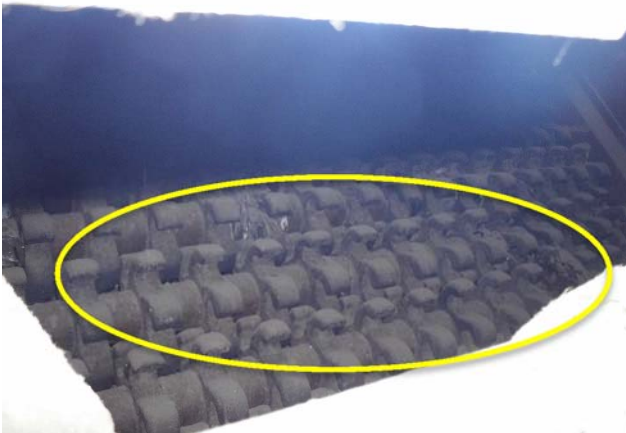
All discs are worn and need to be replaced.

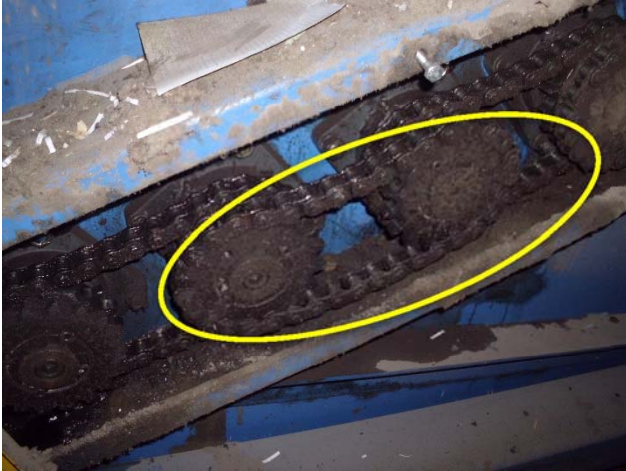
Chains are stretched and sprockets are worn, replacement required.

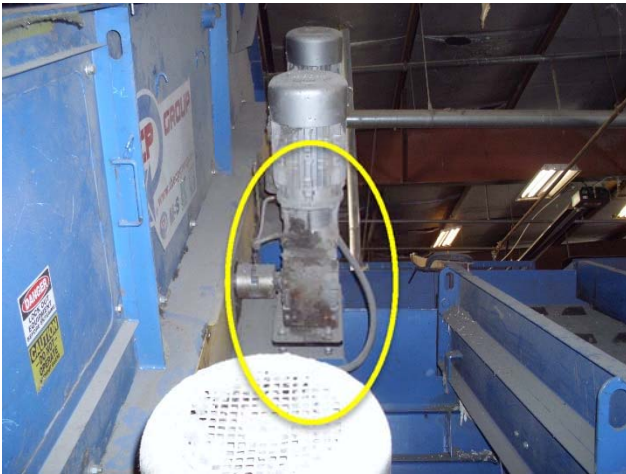
Gearmotors are leaking, replacement required.

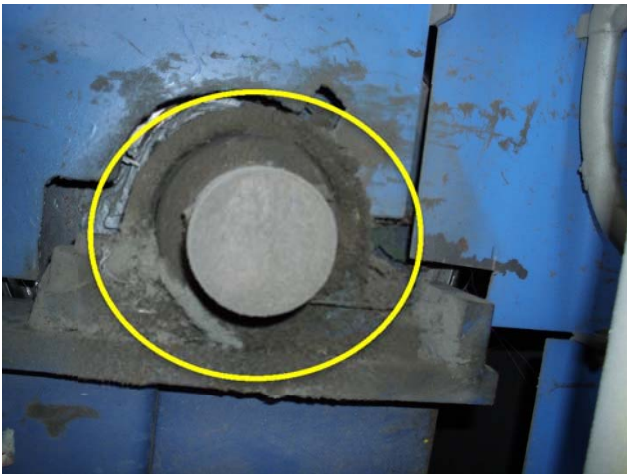
Bearings are blown and need to be replaced.

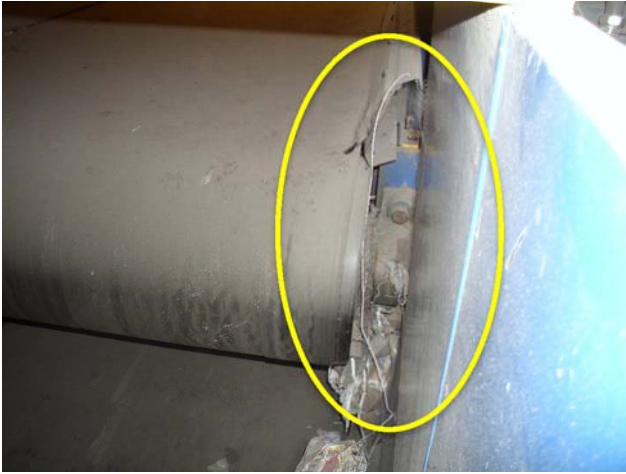
Belt is torn, debris is piled up under belt which is causing the tracking to be off and more strain on the belt.

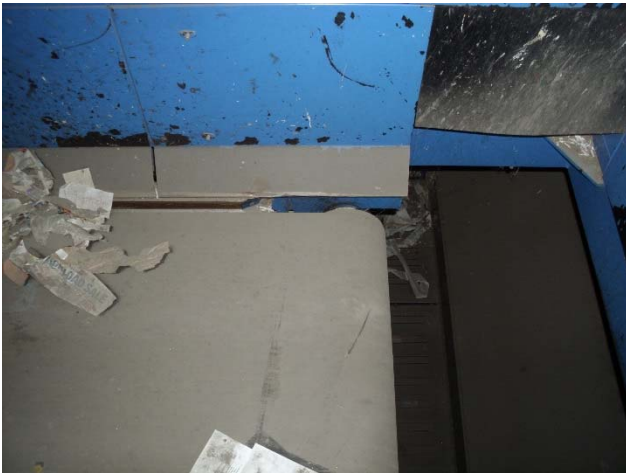
Belt is worn, tracking is off, replacement required.

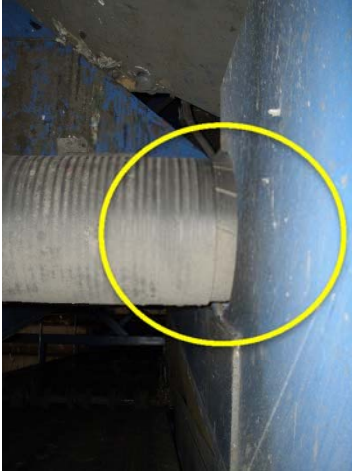
Belt tracking is pulling to the left, belt is worn and needs to be replaced.

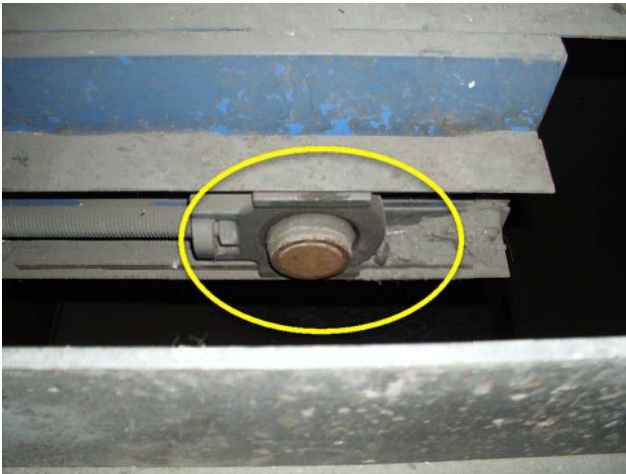
Bearings are worn, replacement required.

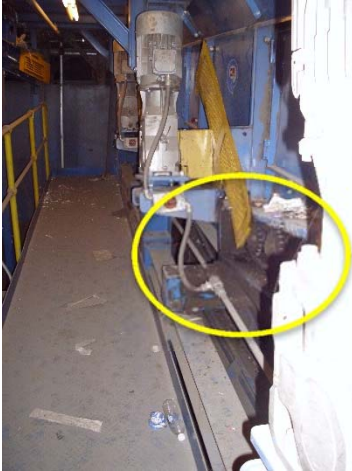
The above pictures show the excessive grease/oil from bearings that are worn, chains are stretched and worn, sprockets are worn, replacement of all components required.

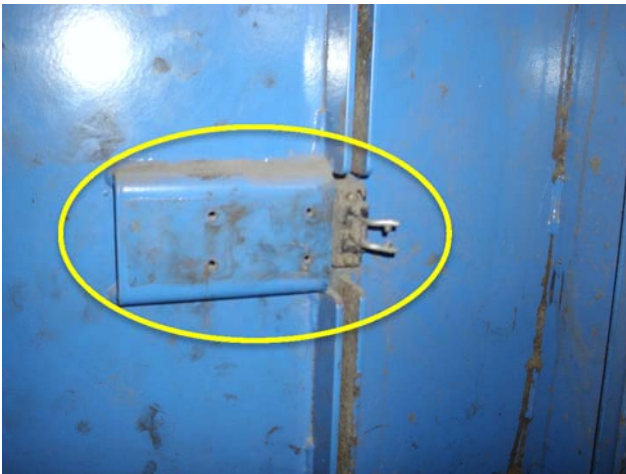
Safety device has been removed. Not OSHA standards, replacement required.

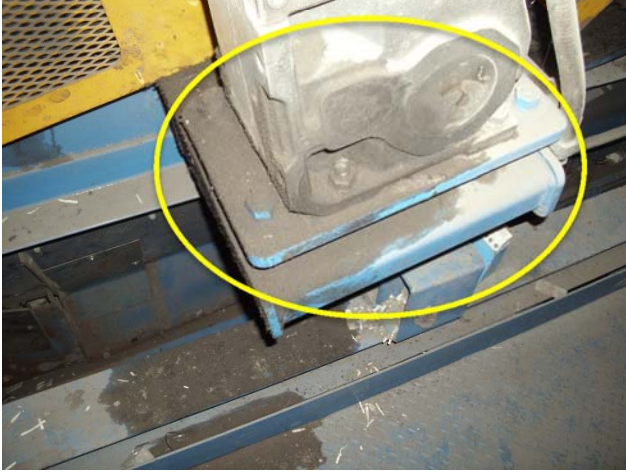
Gearmotor is leaking, replacement required.

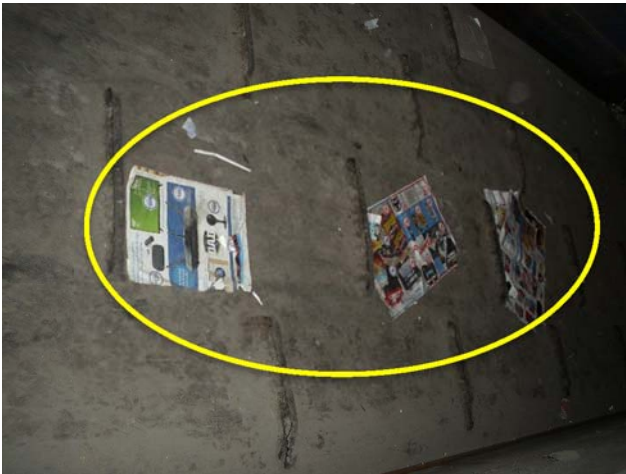
Belt is worn, cleats are barely visible, replacement required.

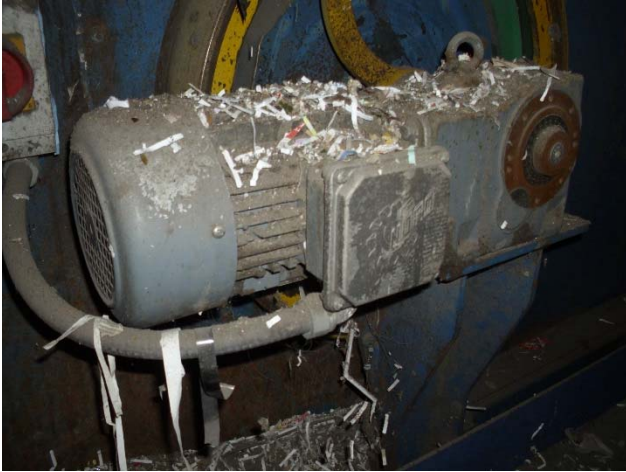
Item #	31B	Motor #	M-31B
Description:	ADS

Equipment needs much work to be fully functional. Bearings needs to be replaced, proper cleaning required, guards are also omitted/missing.

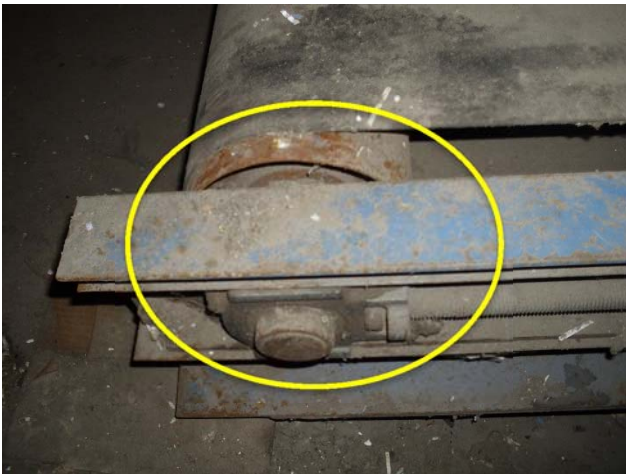
Above picture indicates a severely worn belt, pulley and bearing. Replace all components.

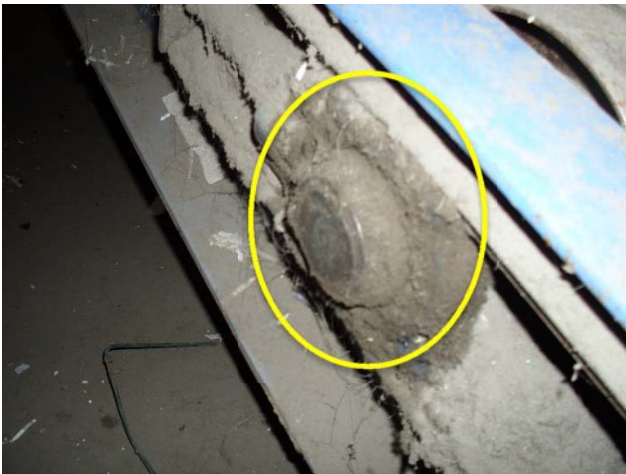
Bearings are worn/broken, replacement required.

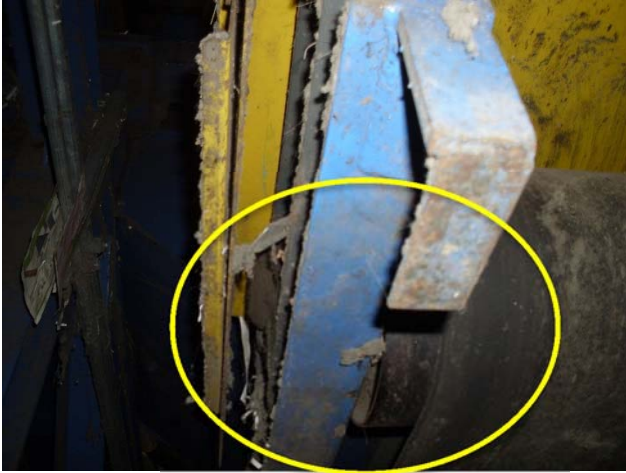
Picture indicates a pulley worn, replacement required. Bearing is worn as well, replacement required.

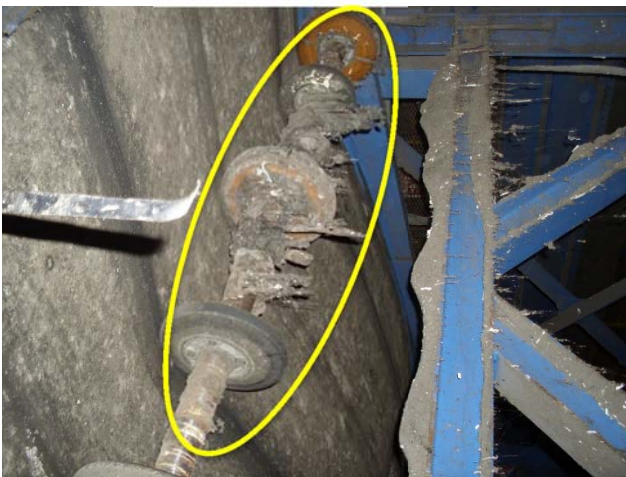
Return rollers are worn, replacement required.

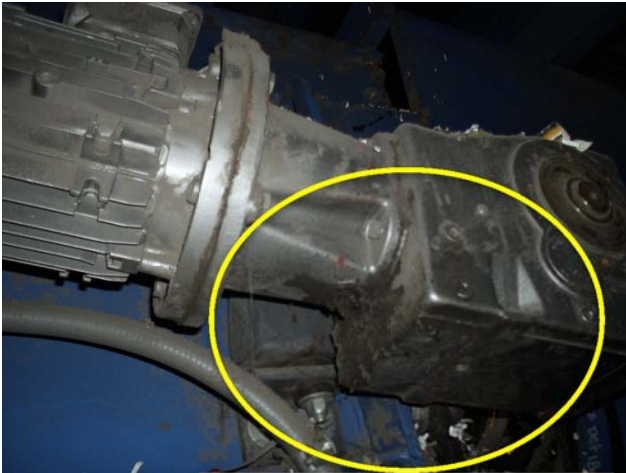
Gearmotor is leaking, replacement required.

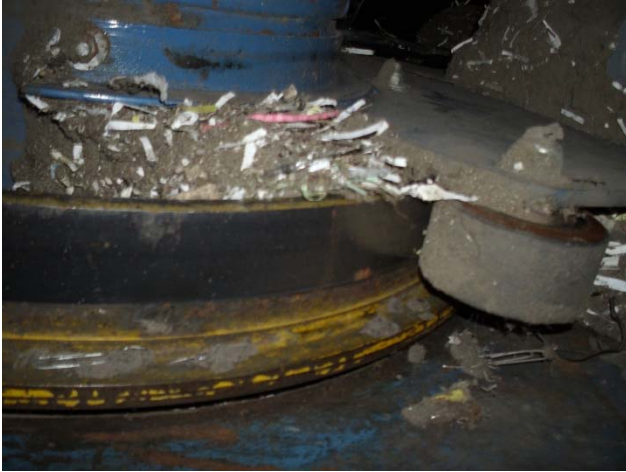
Item #	35	Motor #	M-35
Description:	ADS

Guards are omitted/missing, motor is leaking, replacement required.

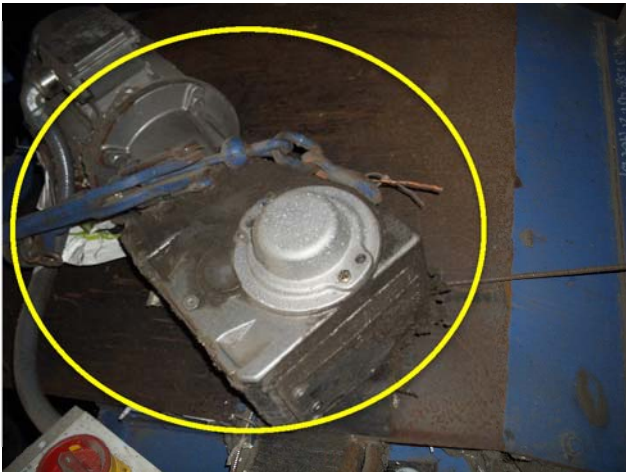
Gearmotor is not secured safely and is leaking, replacement required.

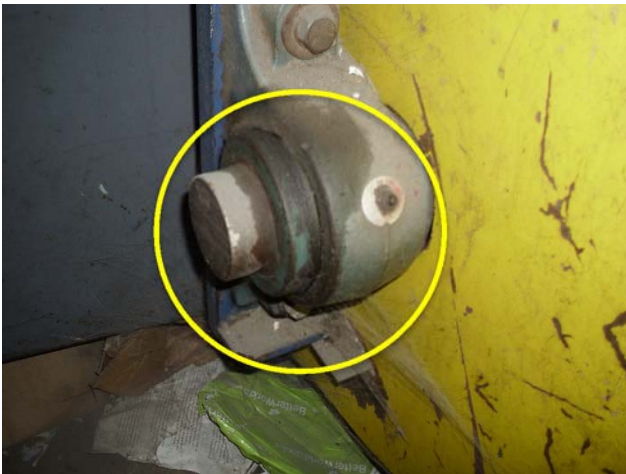
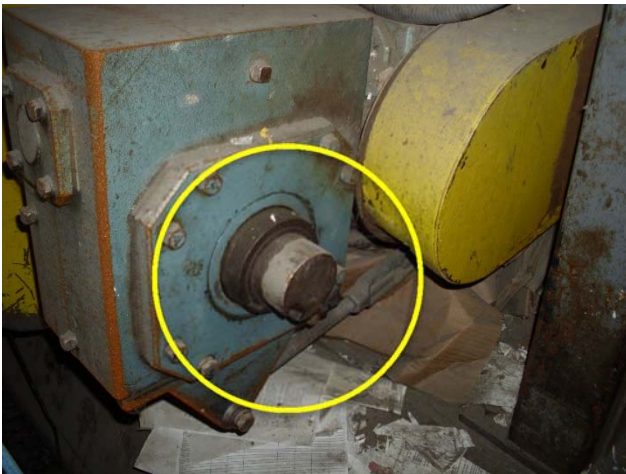
Bearings are blown, replacement required.

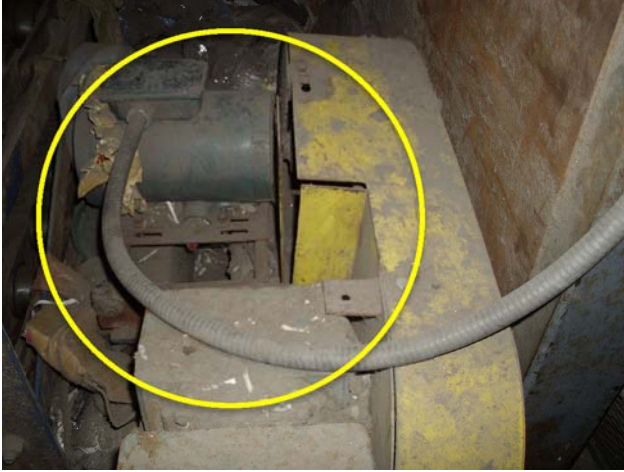
Power unit is filled with debris, replacement required.

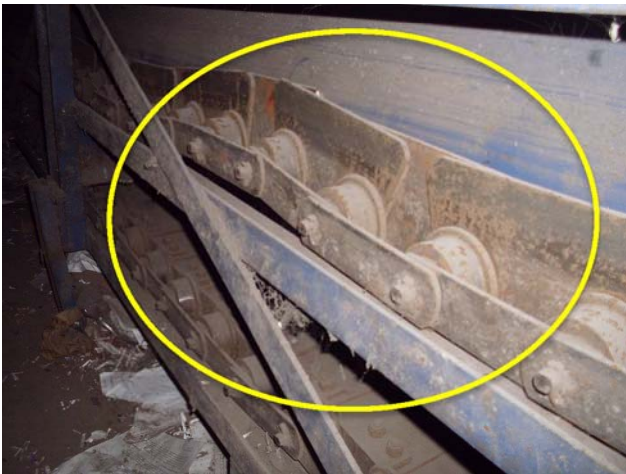
Belt needs to be replaced, tensioning is off as well.

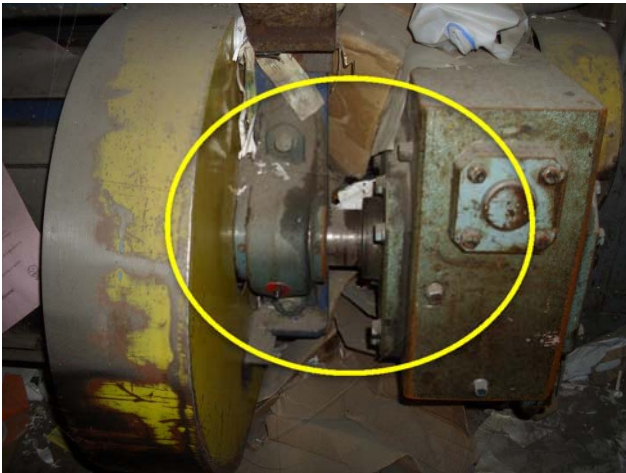
Bearings and gearmotor need to be replaced.

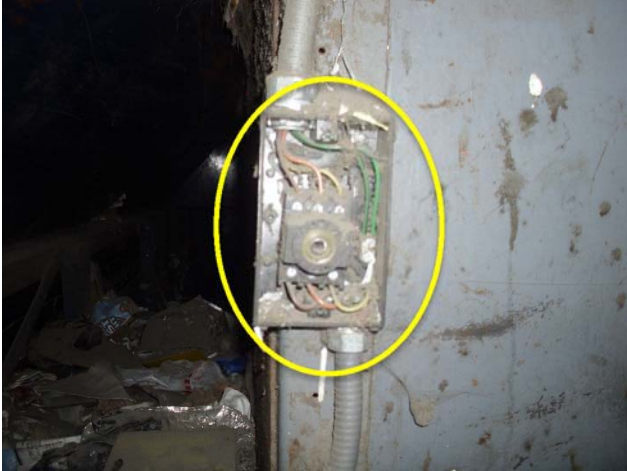
Cover has been removed from wiring. Unsafe exposure.

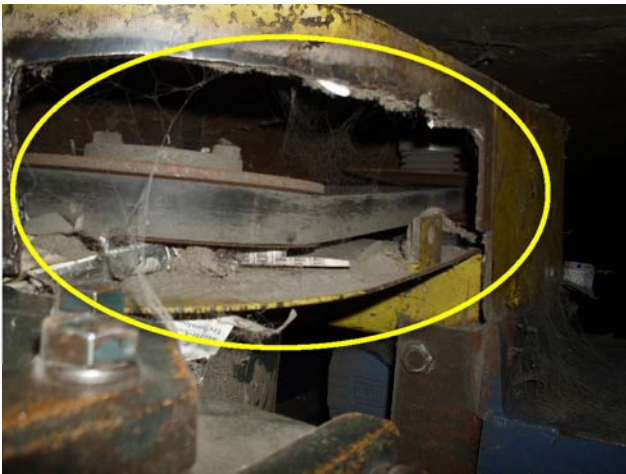
Guarding has been removed.

Conveyor needs to be cleaned for optimal use. All components are worn and needs to be replaced.

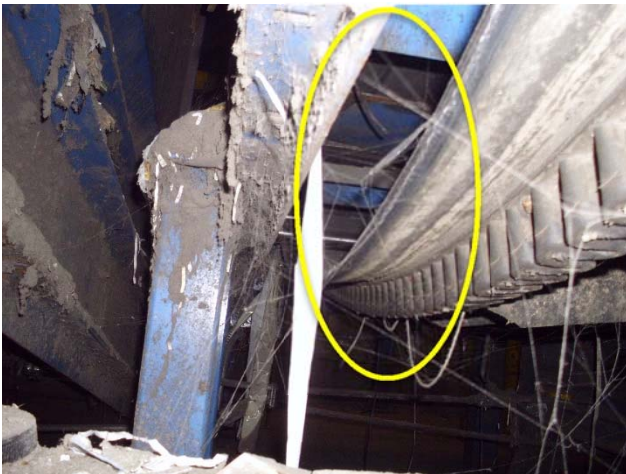
Belt tensioning is off, return rollers required to enhance optimal use.

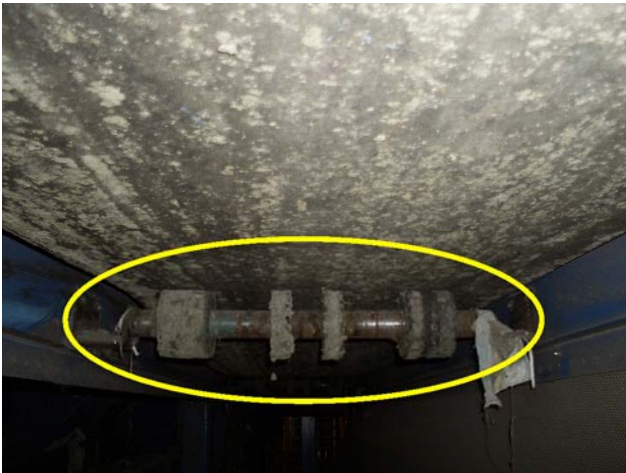
Return rollers are worn and need to be replaced.

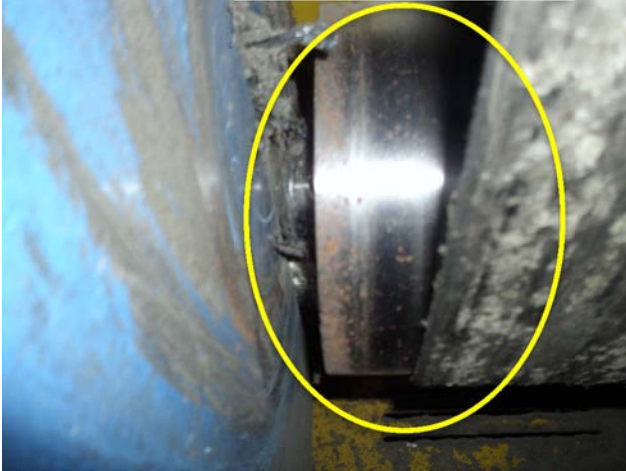
Head and tail pulley needs to be replaced. Belt tracking is pulling to the right.

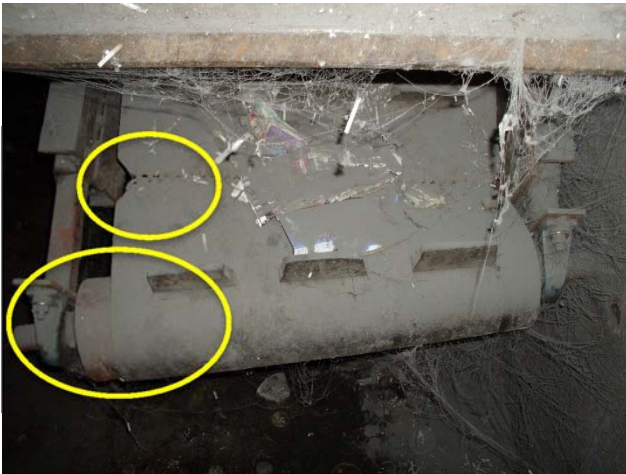
Picture shows belt tracking to the right, lacing and belt torn. Pulleys and bearings need to be replaced.

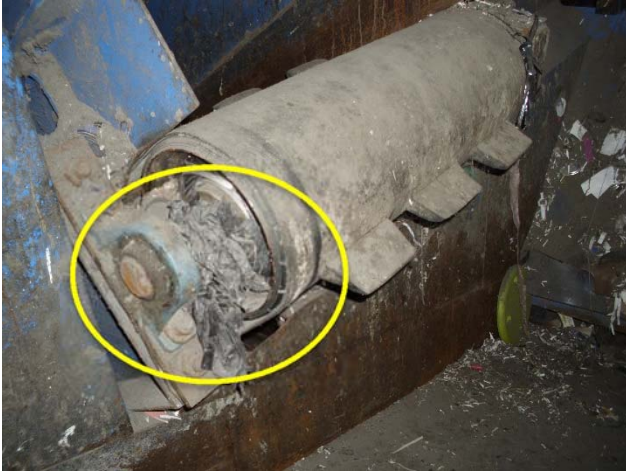
Condition of bearing is worn/blown. Replacement required.

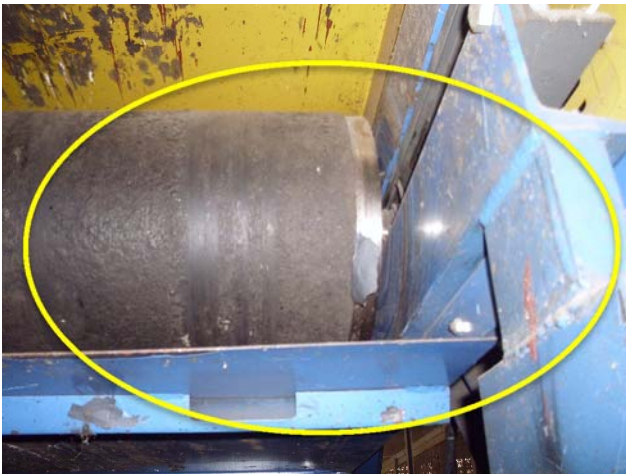
Belt is worn, replacement required. Tracking is off. Pulleys are worn. Bearings are worn.

Replacement of pulleys and bearings recommended.

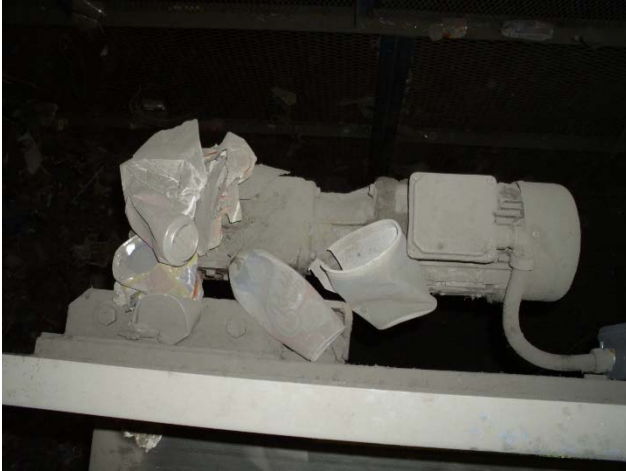
All components on this conveyor need replacement. Both pulleys, bearings, belt, gearmotor, return rollers. Replacement of conveyor recommended.

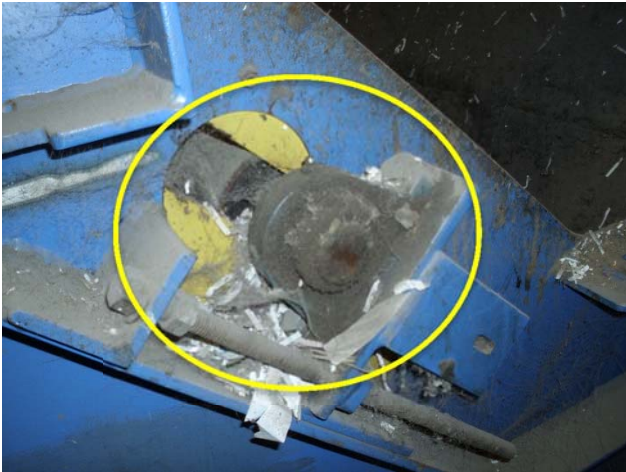
Bearings need to be replaced.

Unit needs to be cleaned, belt needs to be replaced.

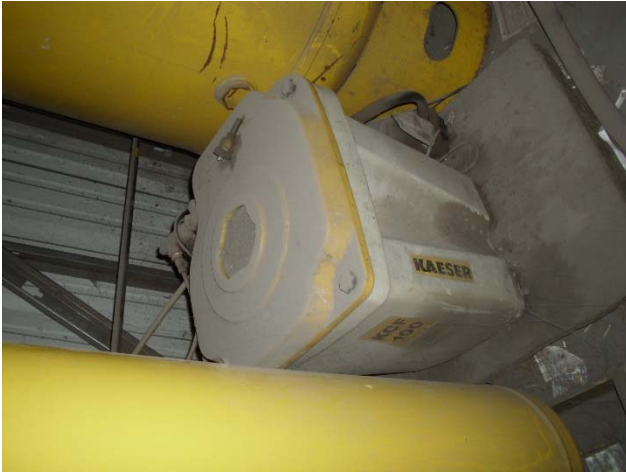
Item #	50B	Motor #	M-50B
Description:	Air Rotary Screw Compressor - Kaeser

Cleaning required.

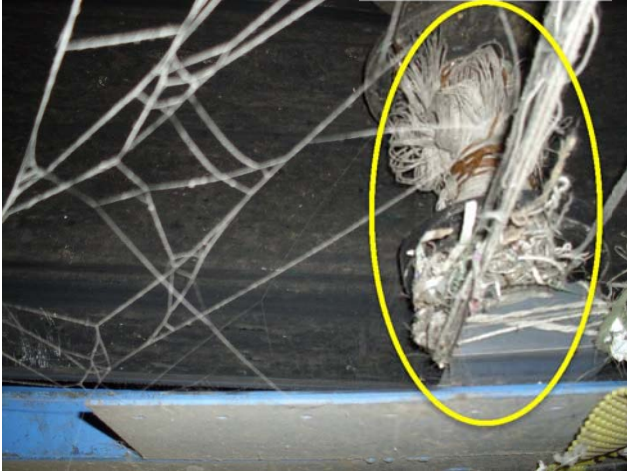
Return rollers are wrapped and worn, replacement required.

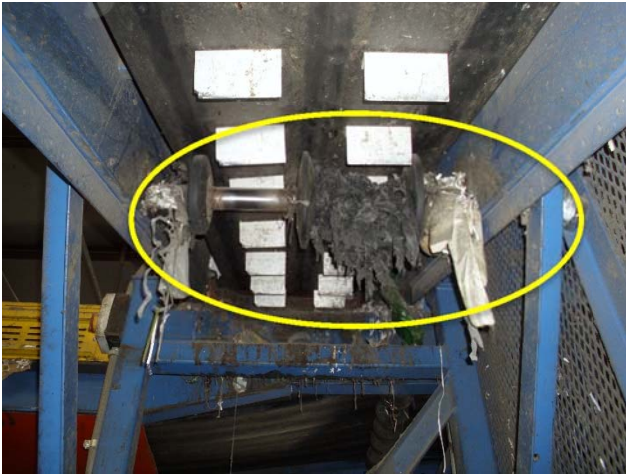
Return rollers are wrapped, cleaning required.

Bearings need to be replaced, head and tail pulley are worn, replacement required.

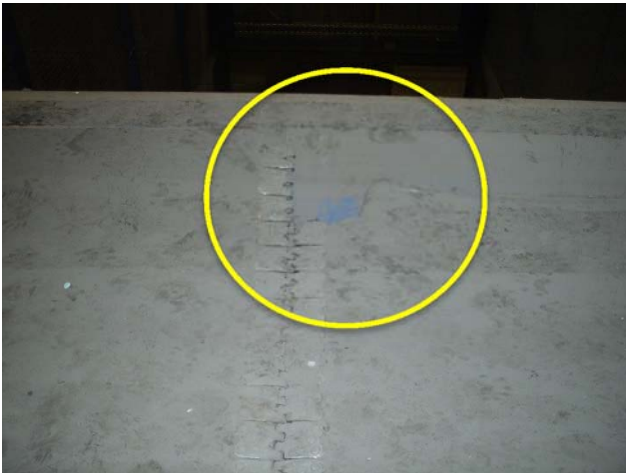
Belt is torn, lacing torn, replacement required.

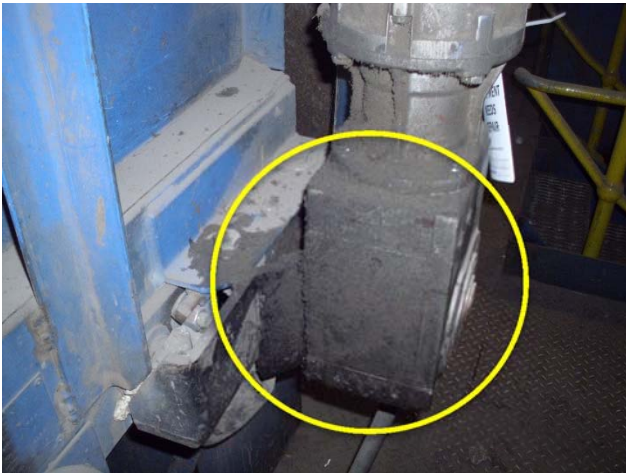
Gearmotor is leaking, replacement required.

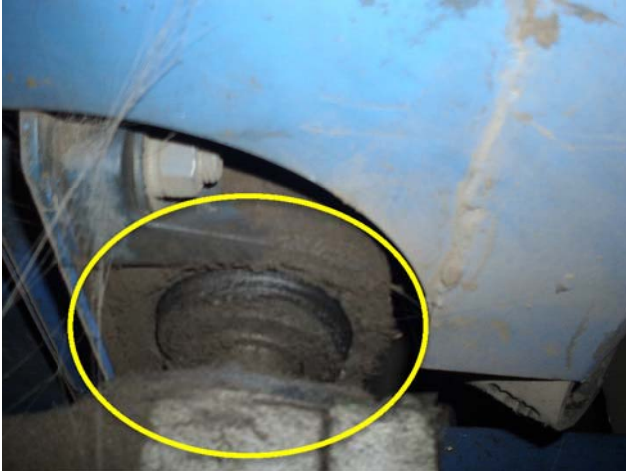
Bearings are worn, replacement required.

Pulleys are worn, replacement required. Return rollers are worn, replacement required. All other components on conveyor are in need of replacement.

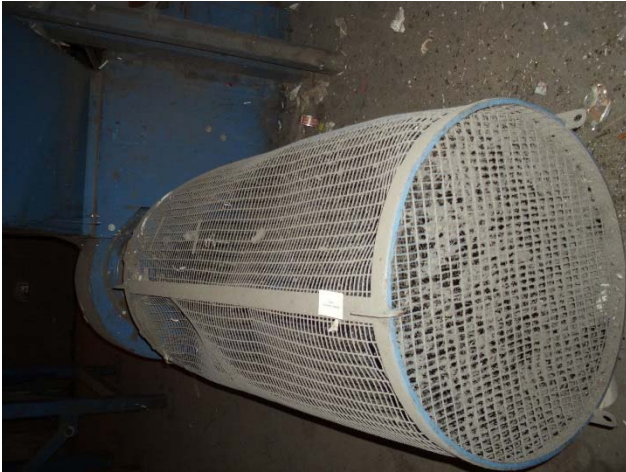
Item #	57	Motor #	M-57
Description:	Aluminum Silo Blower

Cleaning required.

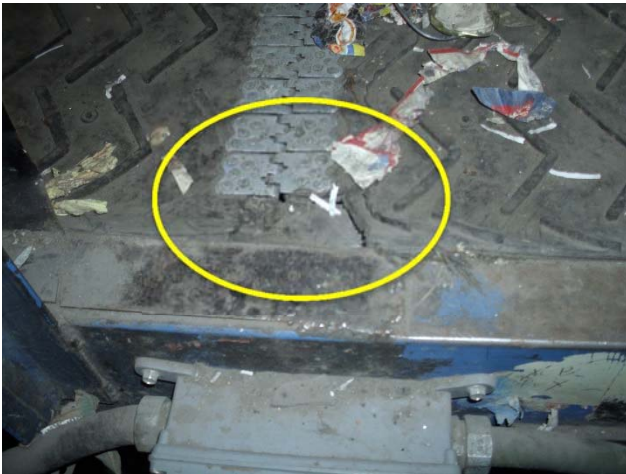
Belt is torn, replacement required.

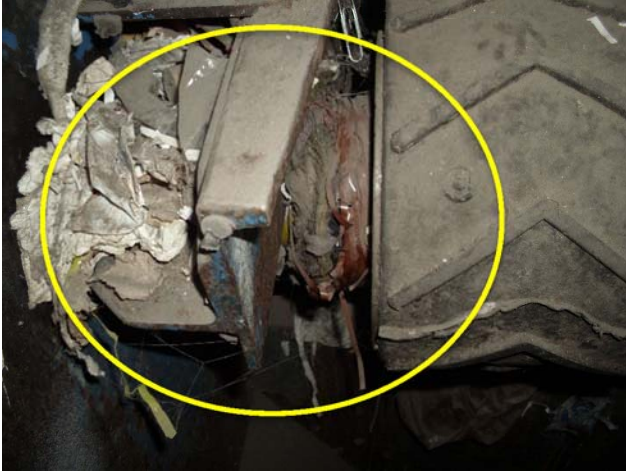
Pulleys are wrapped, replacement required.

Return rollers omitted. Replacement required. All other components on conveyor are in need of replacement.

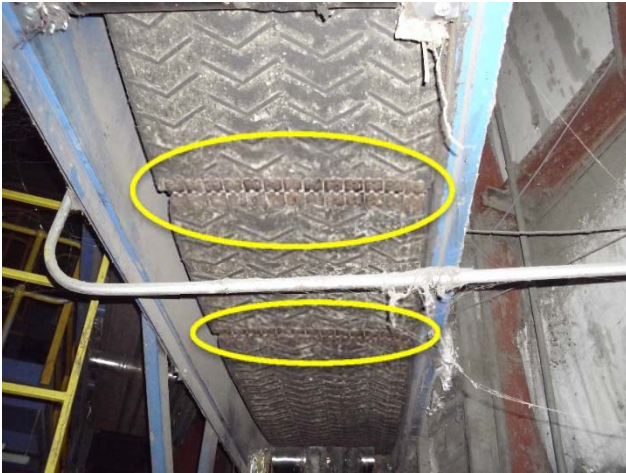
Belt is torn in multiple places, replacement required.

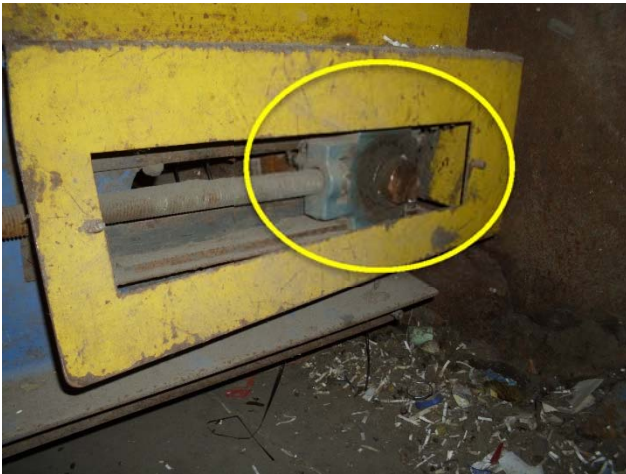
Bearings are worn/blown, replacement required.

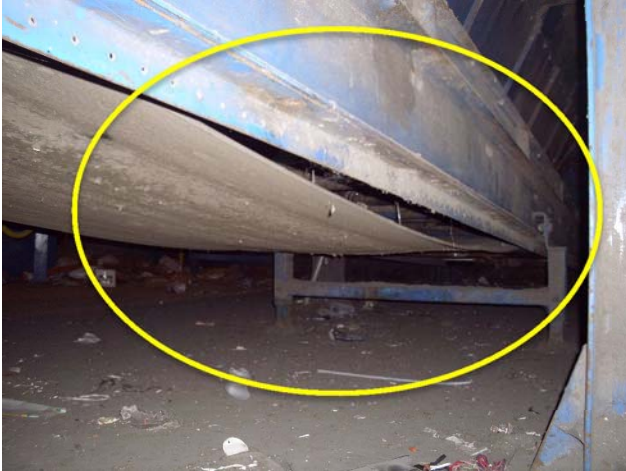
Tensioning is lacking, return rollers omitted. Replacement of rollers required.

Both pulleys on conveyor are showing signs of wear, replacement required. Gearmotor is in worn condition and should be replaced as well.

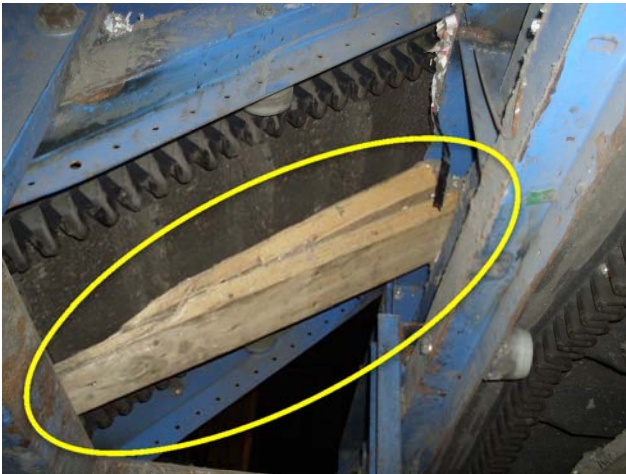
Return rollers are omitted, wood used instead. Immediate replacement required.

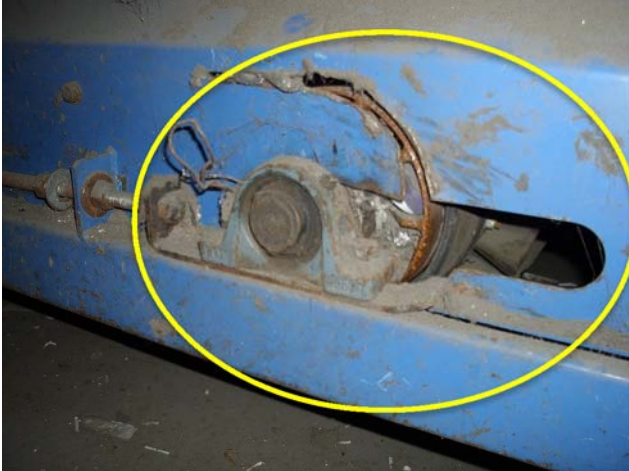
Pulley is worn, bearing is worn, guarding is damaged, replacement of all required.

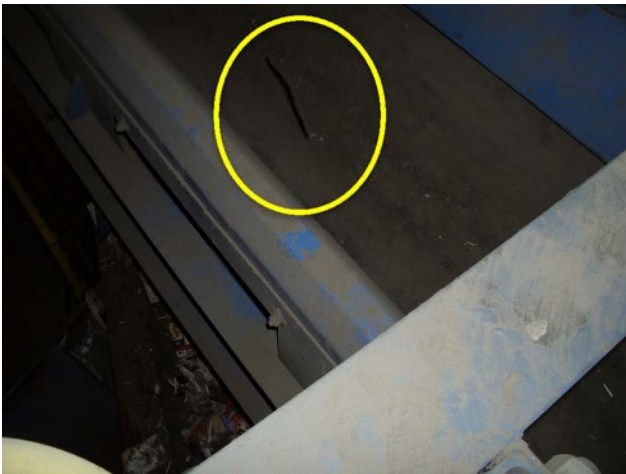
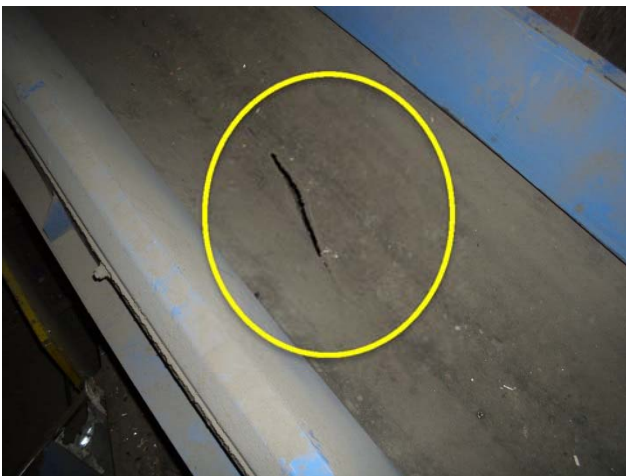
Belt is torn, replacement required.

All components on conveyor is worn or damaged. Both pulleys, all bearings, gearmotor and belt need to be replaced.

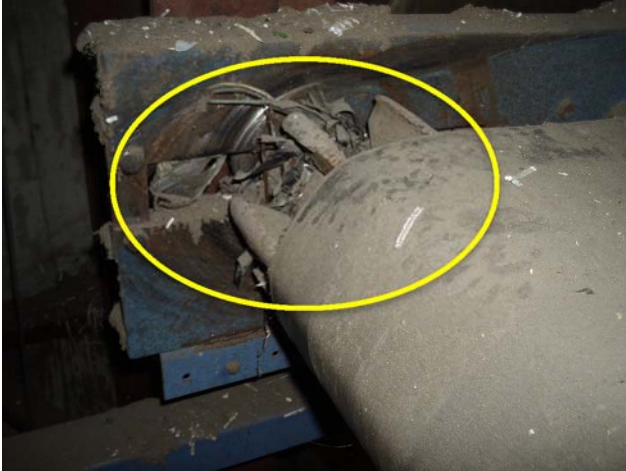
Conveyor pulley shaft is wrapped, bearing and pulley both need to be replaced. Belt is worn and replacement is required.

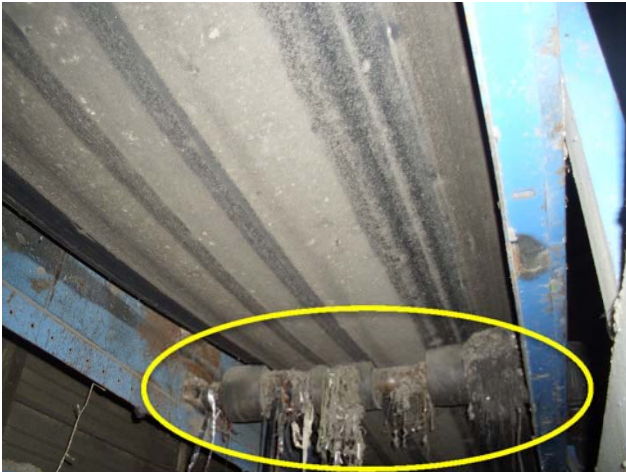
Return rollers are worn, replacement required.
