City of Ann Arbor MRF Audit

Company/Dept.: CP MFG / Customer Service		Title: System Audit		Document Number: Audit

Author: M. Augustyn-Morales	Date: 2/9/2017	Rev 1

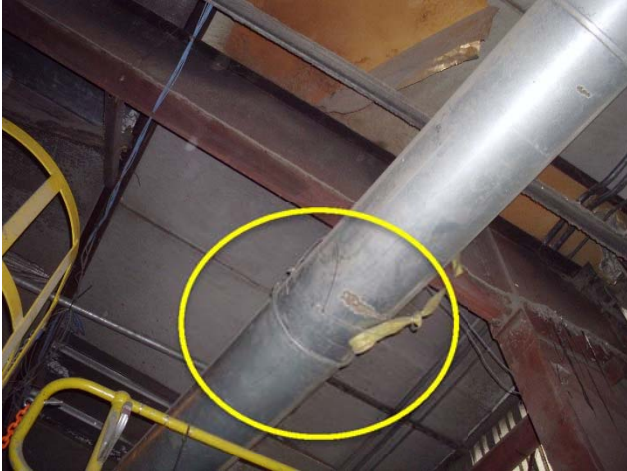
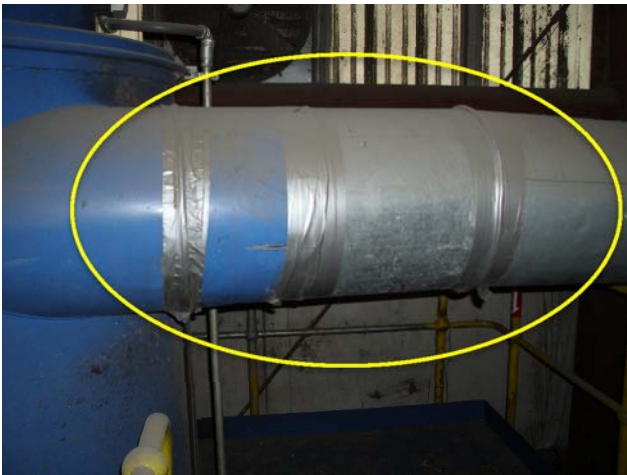
Ducting is held together by wire. Clamp is omitted. Immediate replacement required.

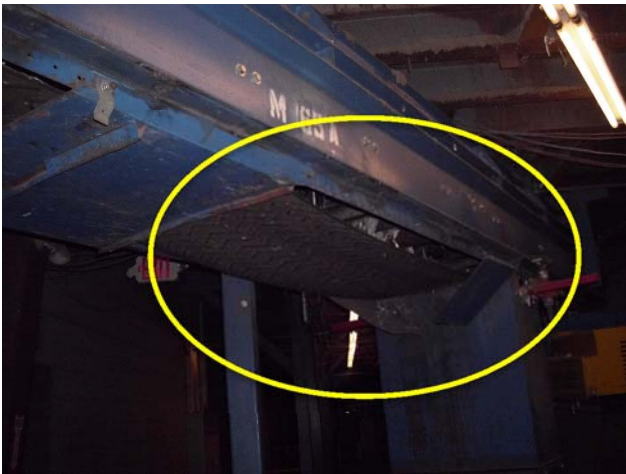
Return rollers omitted. Replacement required.

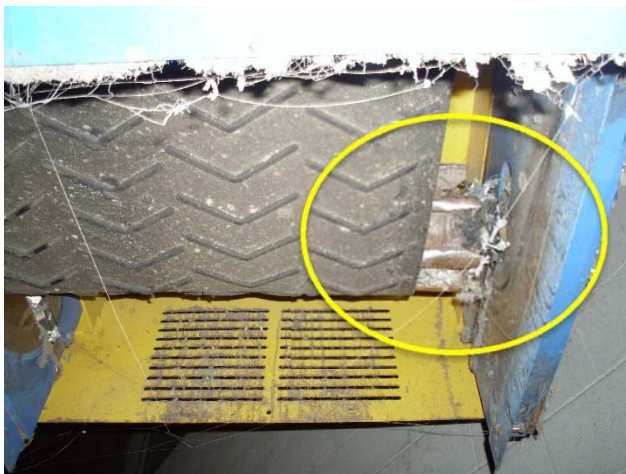
Belt tracking is pulling to the left, pulleys are both damaged beyond repair, replacement of belt, pulleys and bearings recommended.

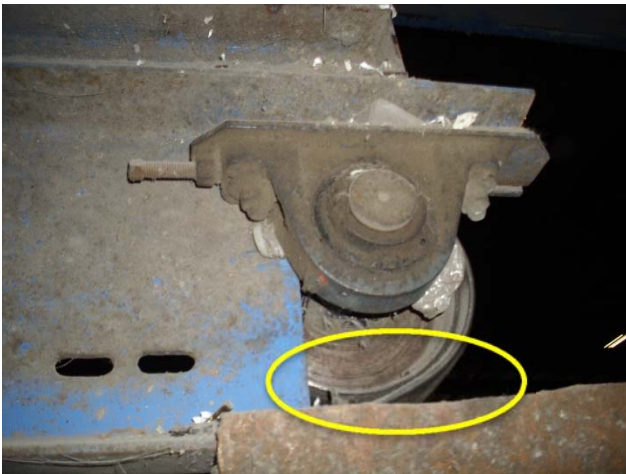
Return rollers are damaged. Replacement required.

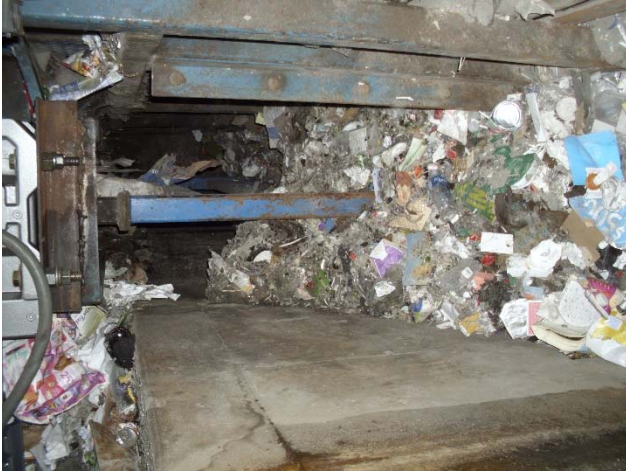
The trash pile up on this conveyor has made it impossible for the technician to do a proper inspection of all components. From the pictures it can be said that this conveyor is in a very worn state and cannot function properly without correction of most components.
