City of Ann Arbor MRF Audit

The following report is a maintenance and operations evaluation of the equipment installed at the City of Ann Arbor Materials Recovery Facility by CP Manufacturing. The information gathered for this report was collected by Craig Frisch, Senior Field Project Manager. This information was gathered over a two day period.

Company/Dept.: CP MFG / Customer Service		Title: System Audit		Document Number: Audit

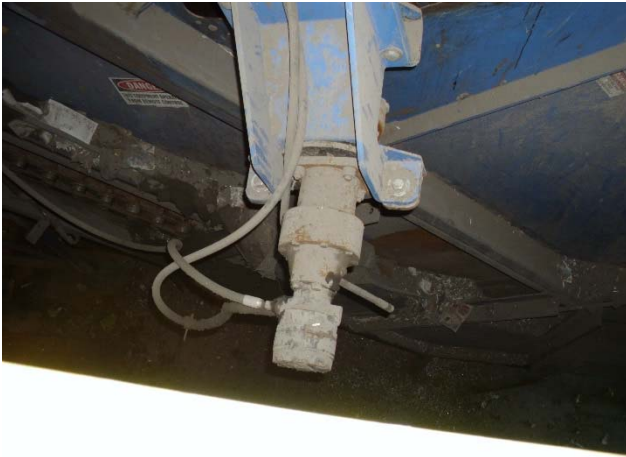
Hydraulic Lines needs to be replaced and/or fixed.

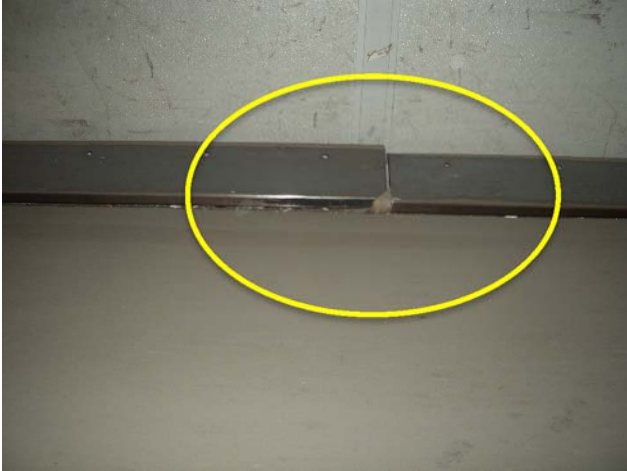
Guarding needs to be replaced.

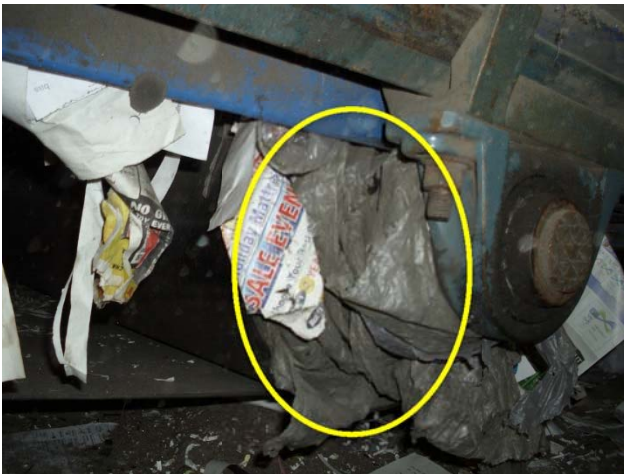
Shafts are wrapped and needs to be cleaned.

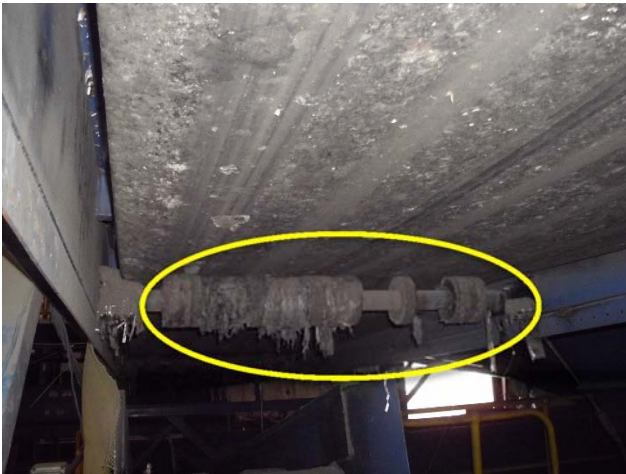
Return rollers are wrapped and worn, replacement required.

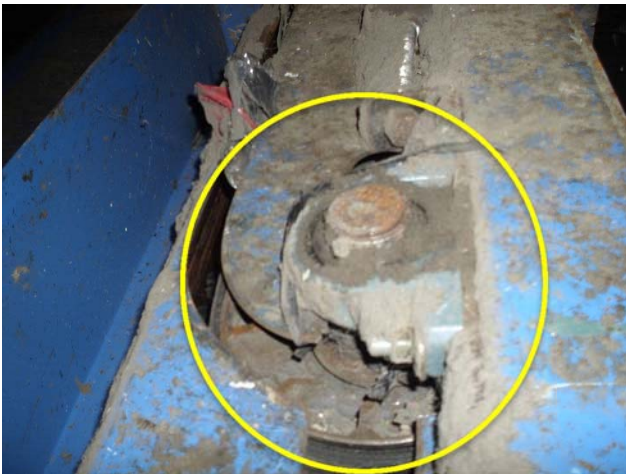
Both head and pulleys and bearings are worn and need replacement.

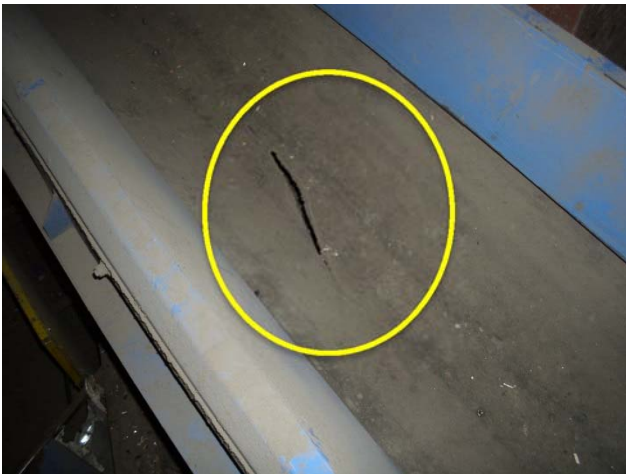
Belt is torn, replacement required.

All components on conveyor is worn or damaged. Both pulleys, all bearings, gearmotor and belt need to be replaced.
