CITY OF ANN ARBOR
MATERIAL RECOVERY FACILITY
4150 Platt Road
Ann Arbor Michigan, 48108

PROCESS SYSTEM
INSPECTION REPORT

Ann Arbor – Inspection Report

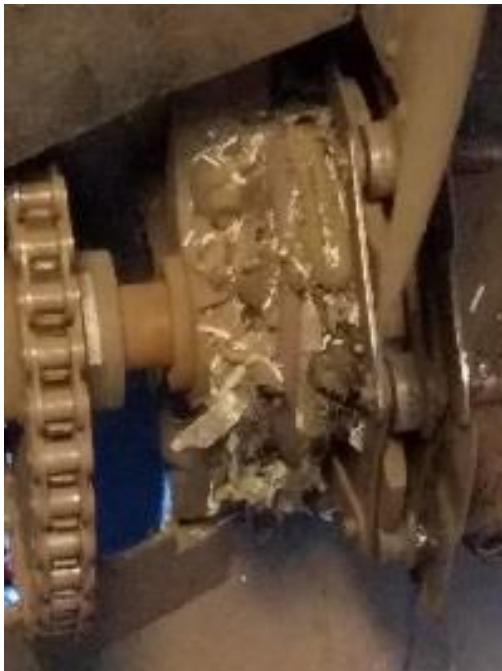
Ref A3, A9

- Steel Belt Separating
- Guarding under head pulley missing
- Loose electrical wire on motor
- Wrappings on head pulley shaft

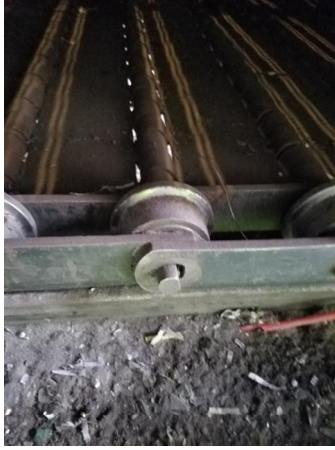
Ref A9

- Guarding missing, open exposed chain accessible
- Missing link pin and worn roller wheels on chain
- Bent support, not lagged to floor
- Heavily worn sideboards at Metering Drum and below
- Belly pan under head pulley bulging apart from material buildup
- Bent cleats
- Tail Guard not secured

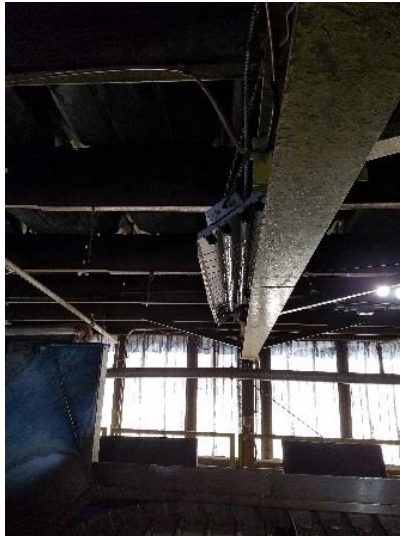
Ref A13, A14

- Loose conduit hanging from wall
- Improper lighting support over Q.C. station
- Electrical Line crimped
- Chute(s) stuffed with material
- Floor deck lifting in areas
- Bottom step to presort bent

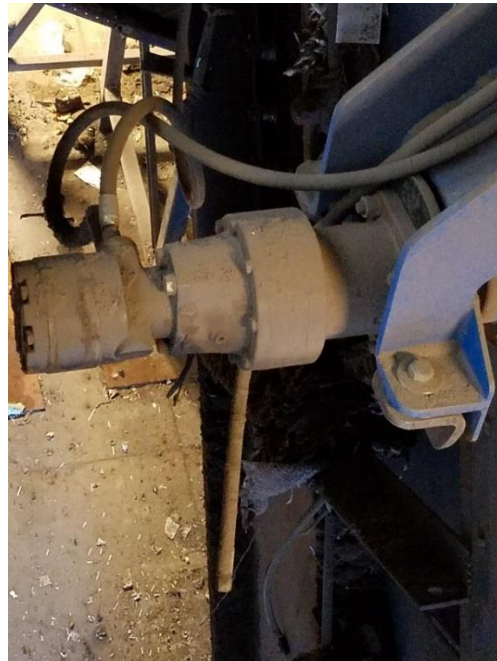
Ref A4, A10

- Loose hydraulic lines and leaking hydraulic power pack
- Worn drum and cleats
- Wrappings on drum shafts

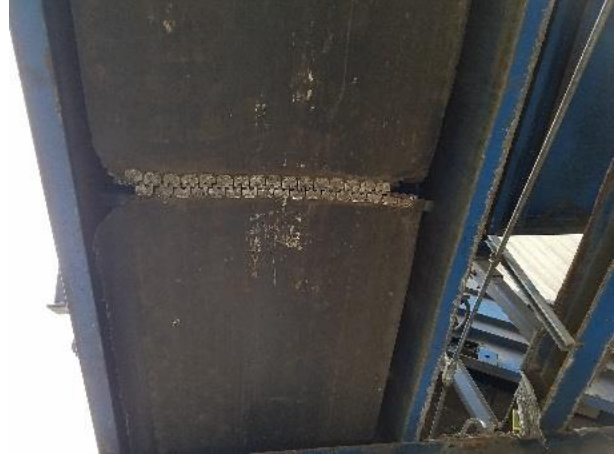
Ref A2, A5

- Bent head pulley and wrapping on shaft
- Belt heavily worn and damaged lacing
- Return Rollers missing

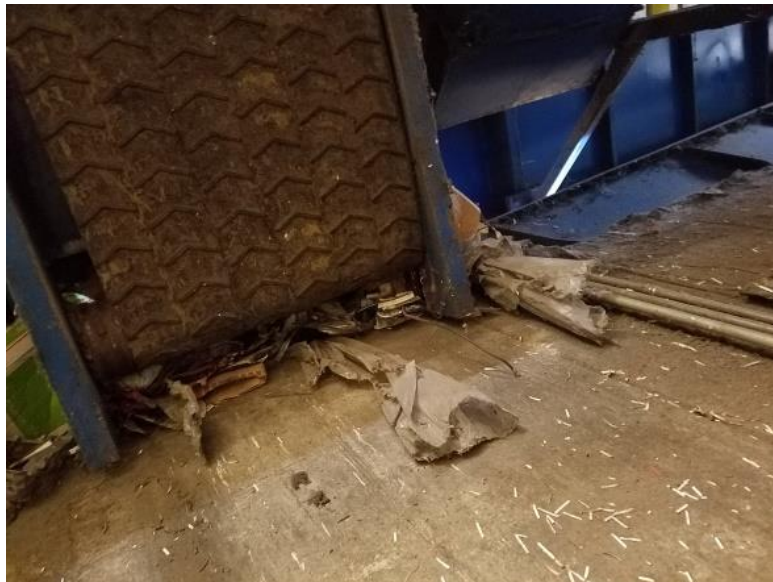
Ref A3, A5, A6

- Wrapping on head pulley
- Gearbox possibly leaking
- Belt not tracked and cutting sideboard

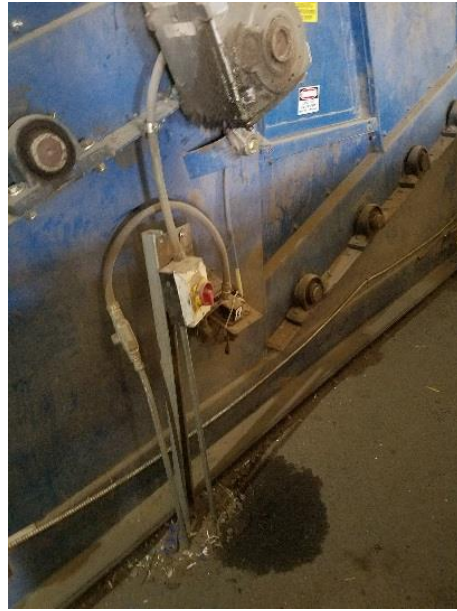
Ref A4, A14

- Bearing bolt missing
- Gearbox leaking
- Oil reservoir missing/broken
- Motor fan cover missing screw
- Motor seal-tight damaged
- Teeth on Discs heavily worn
- Transfer plate at Infeed worn thru
- Additional Fall Protection needed on right side ladder (overlooking Tip Area)

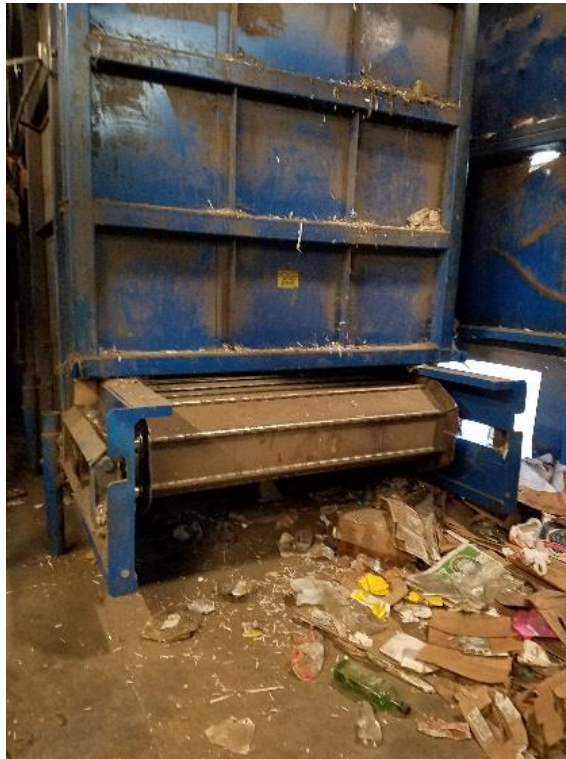
Ref A8

- Missing E-stop
- Missing Tail Guard

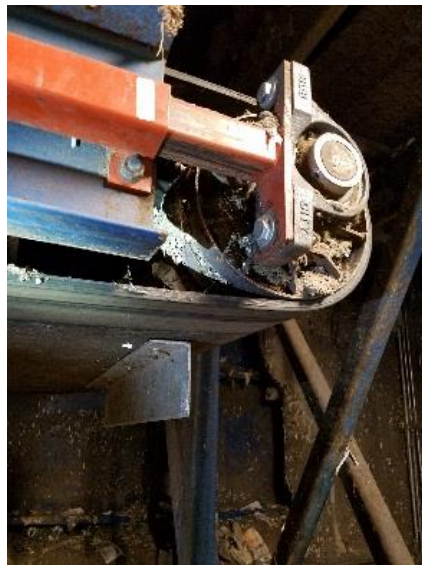
Ref A3, A8, A10

- Belly Guards missing
- Self-cleaning Tail Pulley packed with material
- Windings on tail shaft
- Return Rollers worn
- Feed chute packed with material and worn
- Upturn Return Roller missing from radius

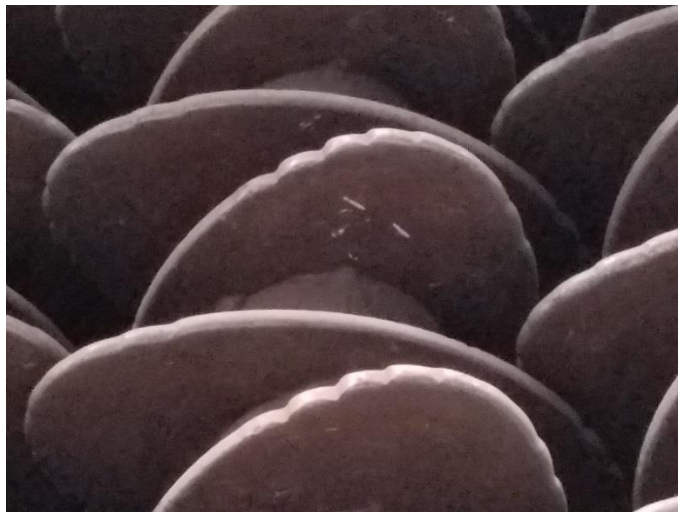
Ref A2

- Leaking Drive Motor
- Bent Handrail adjacent
- Heavily worn discs

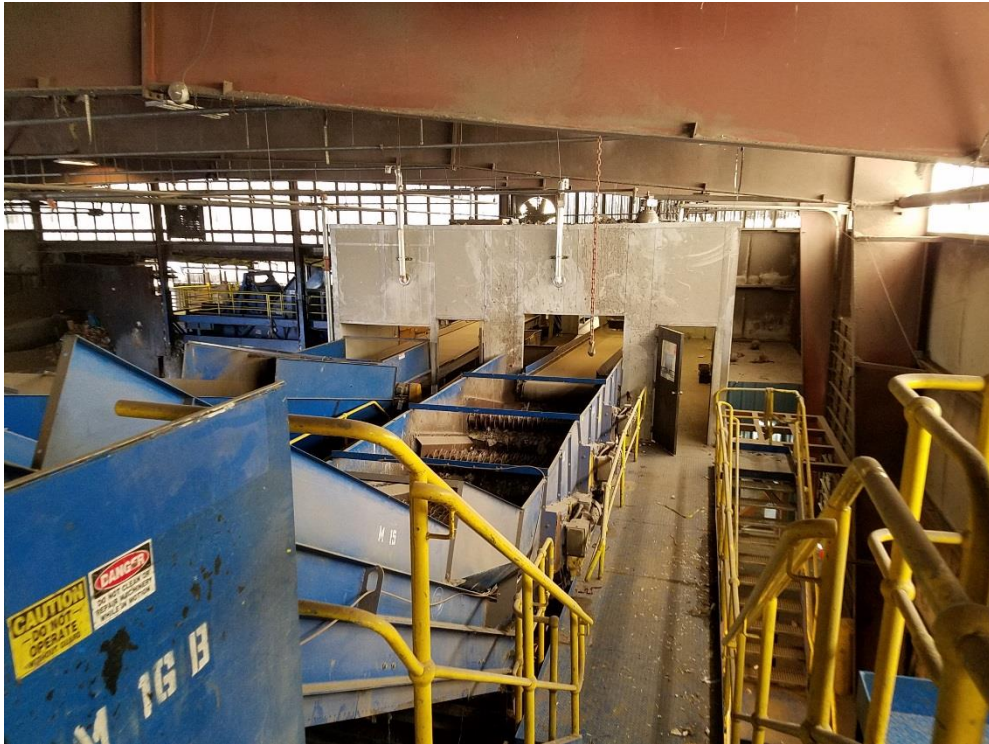
POS M-15 Scalping Screen – Post Sort

- No observable deficiencies

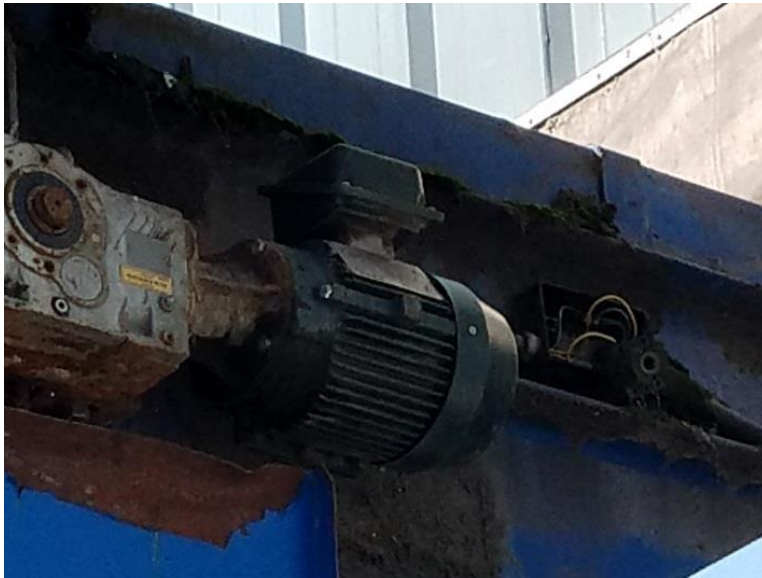
Ref A10, A14

- Open Electrical Box
- Return Roller buildup

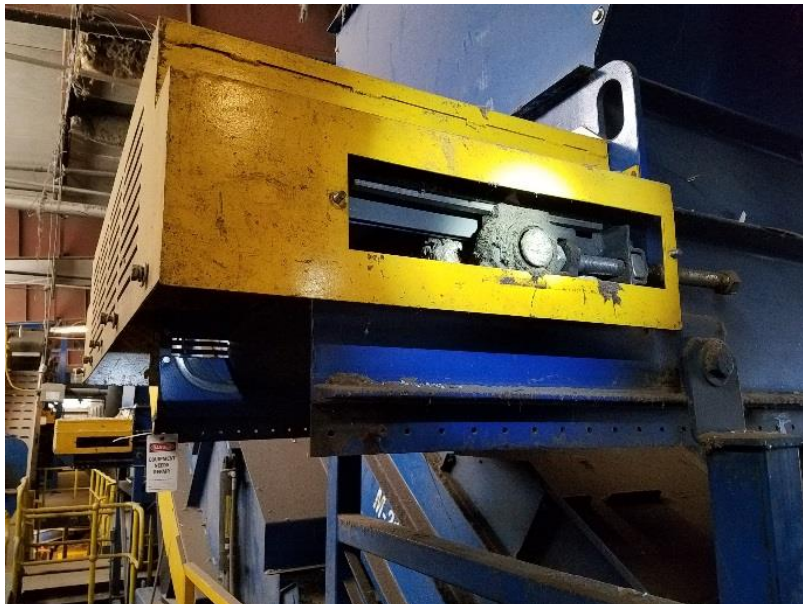
Ref A8, A10

- Belt edge torn
- Wrapping on Return Roller
- Tail Bearing Guard missing
- Missing Belly Pan at Tail
- Bearings worn
- Tail Shaft worn

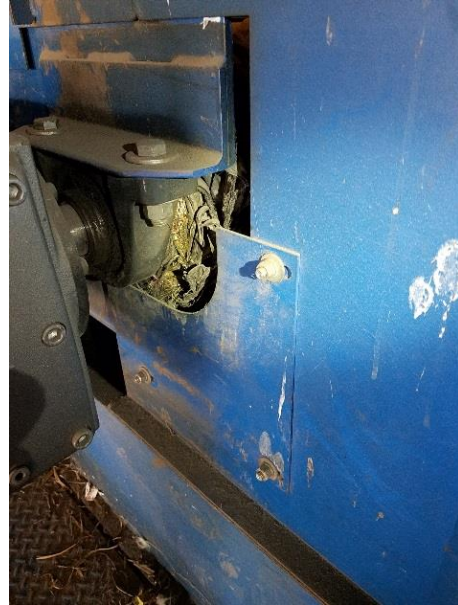
Ref A3

- Belt torn along edge
- Wrappings on Head Pulley
- Missing Belly Guard

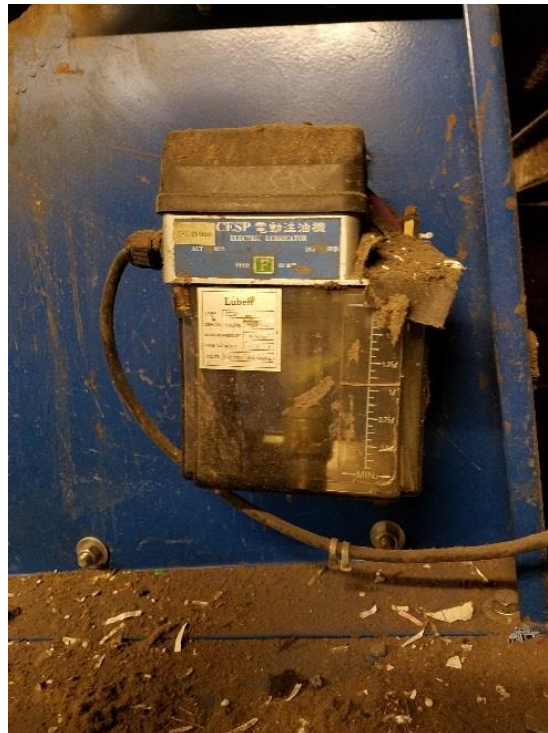
Ref A4

POS M-30 ADS Feed Conveyor

- Worn Cleats
- Missing/Damaged Return Rollers
- Missing Belly Guards

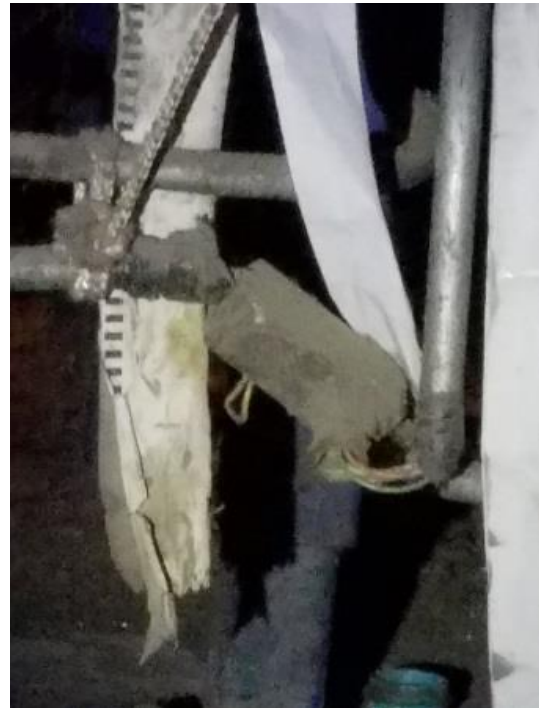
Ref A14

POS M-33 Fiber Transfer Conveyor

- Missing Tail Guard
- Loose/Worn/Patched Belting

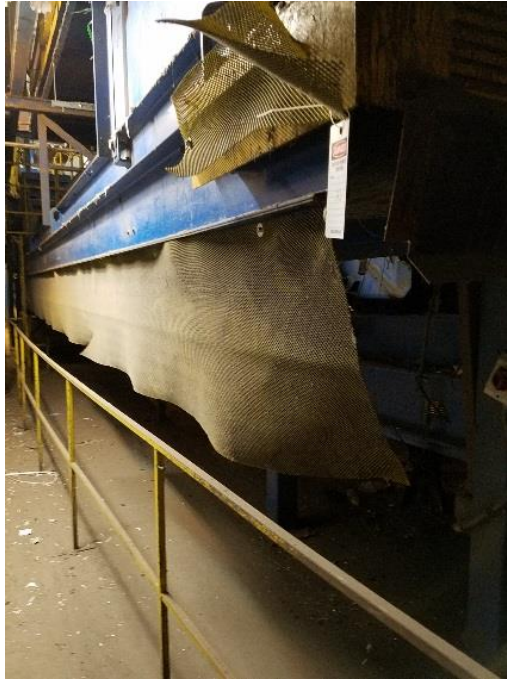
Ref A8

POS M-45 B&C Transfer Conveyor

- Questionable guarding material
- Buildup on Return Rollers

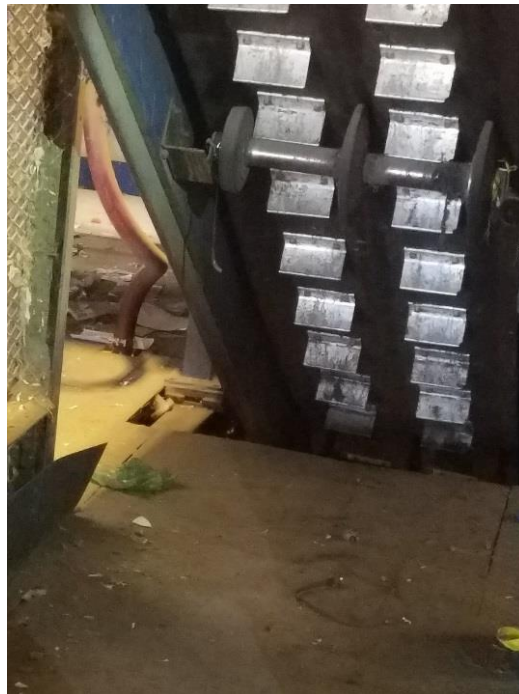
Ref A8

POS M-54 Container Sort Conveyor

- Missing Belly Guard
- Missing Return Roller, others ground flat
- Torn Belting at lace and shredded edge

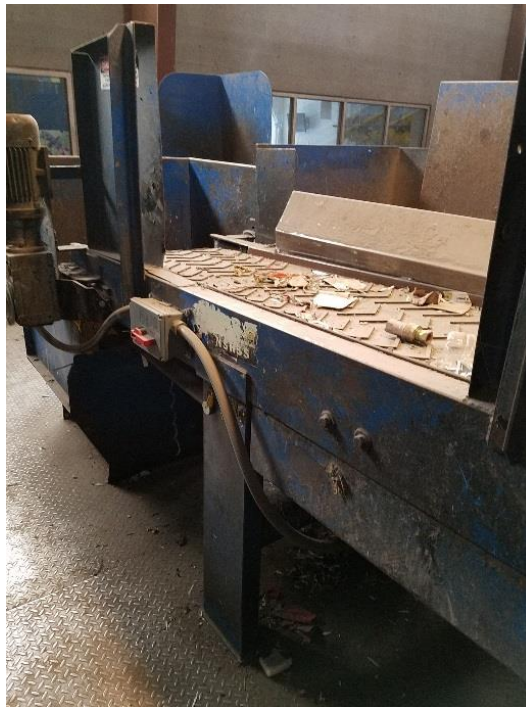
Ref A8, A12

POS M-59 Trash Transfer Conveyor

- Return Roller Buildup
- Heavy Belt Wear

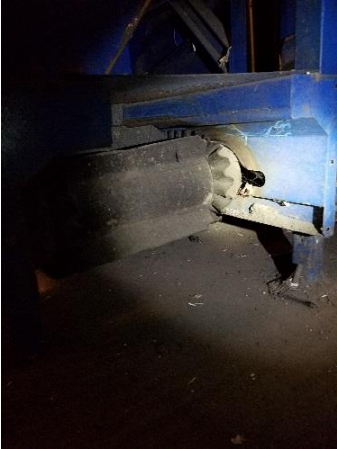
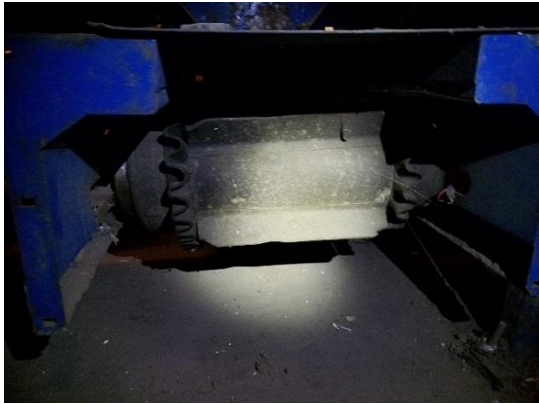
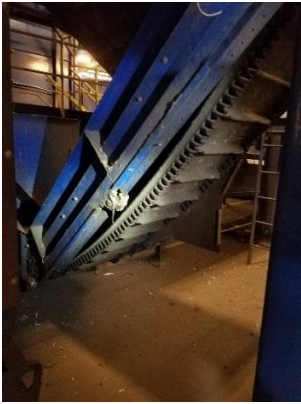
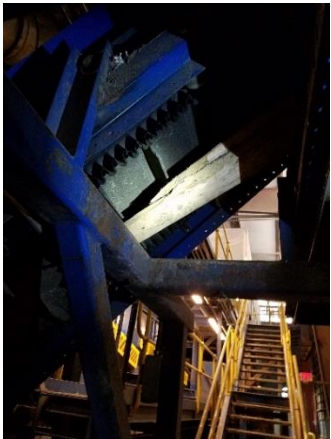
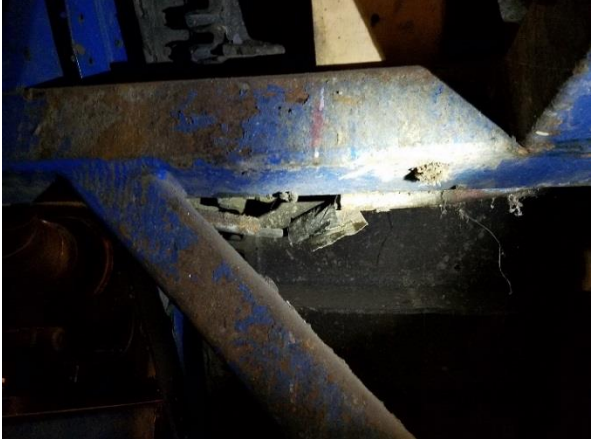
- Tail Pulley wearing thru take-up
- Belt heavily worn
- Missing Tail Guard
- Belt Return Roller Jammed & Bypassed
- Wood used to hold up belting
- Broken electrical conduit

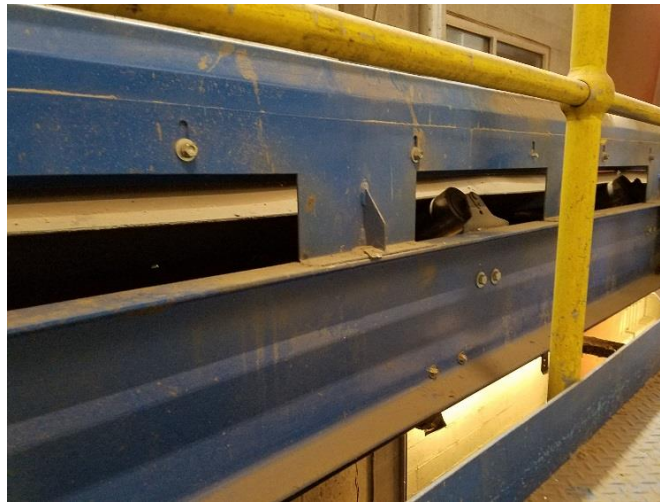
Ref A8

- Torn Belting
- Missing Tail Guard
- Missing Idler guards

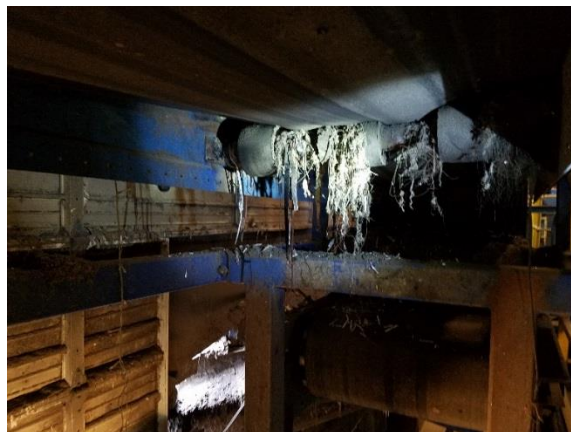
Ref A2, A3, A8

- Missing Tail Guard
- Heavily worn Return Rollers
- Drive Leaks

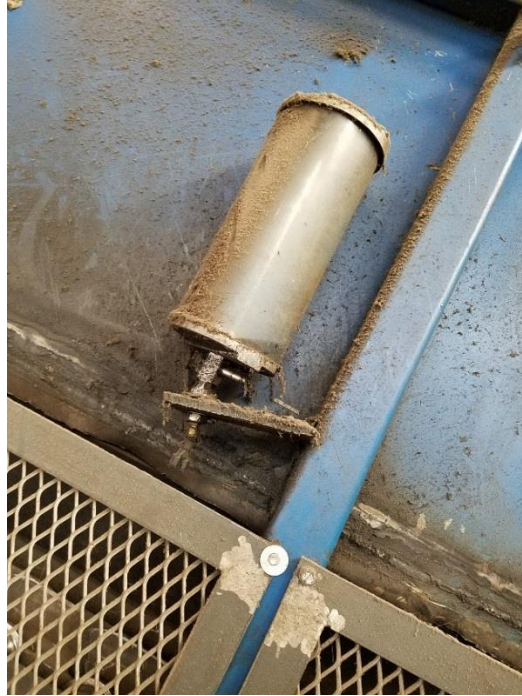
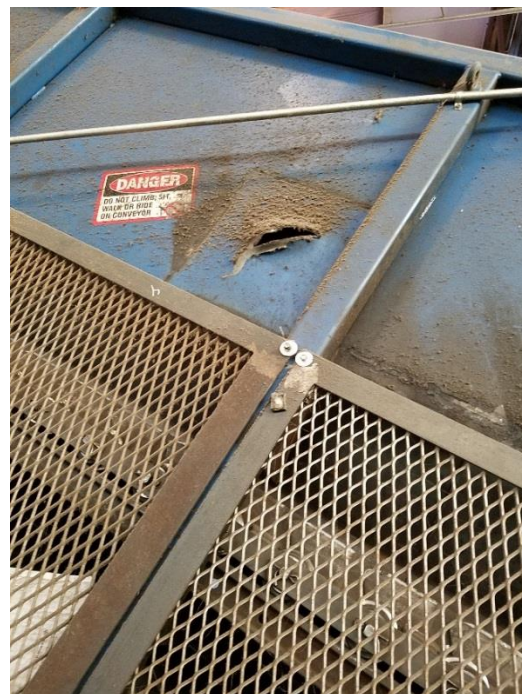
POS M-72 Baler Feed Conveyor

- Automatic Oiler empty and disconnected
- Torn Sideboard on incline portion
- Some Chain Rollers not turning
