CITY OF ANN ARBOR
MATERIAL RECOVERY FACILITY
4150 Platt Road
Ann Arbor Michigan, 48108

PROCESS SYSTEM
INSPECTION REPORT

December 16, 2016

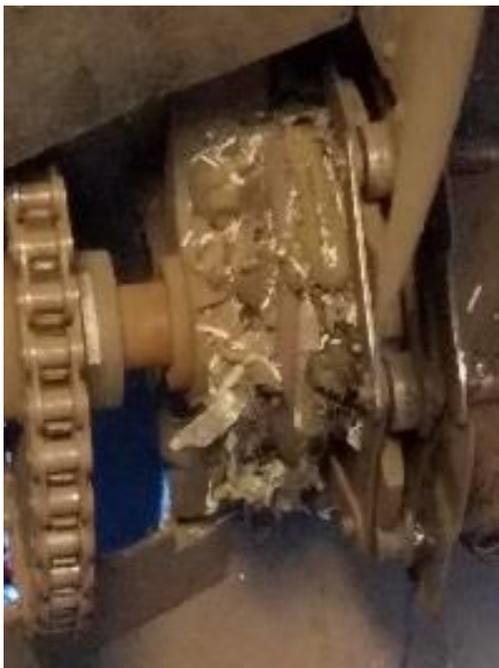
Ref A3, A9

- Steel Belt Separating
- Guarding under head pulley missing
- Loose electrical wire on motor
- Wrappings on head pulley shaft

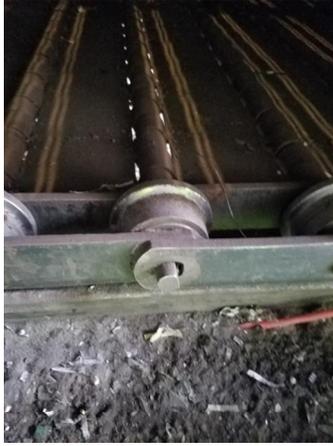
Ref A9

- Guarding missing, open exposed chain accessible
- Missing link pin and worn roller wheels on chain
- Bent support, not lagged to floor
- Heavily worn sideboards at Metering Drum and below
- Belly pan under head pulley bulging apart from material buildup
- Bent cleats
- Tail Guard not secured

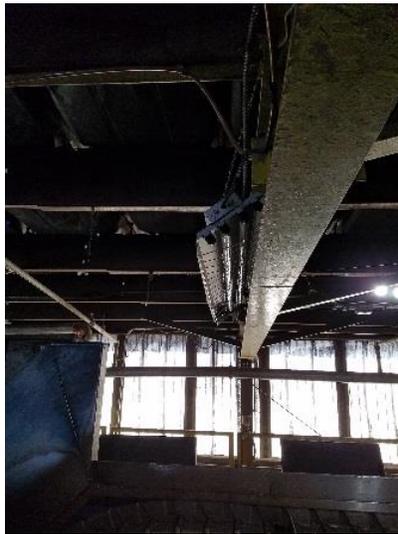
Ref A13, A14

- Loose conduit hanging from wall
- Improper lighting support over Q.C. station
- Electrical Line crimped
- Chute(s) stuffed with material
- Floor deck lifting in areas
- Bottom step to presort bent

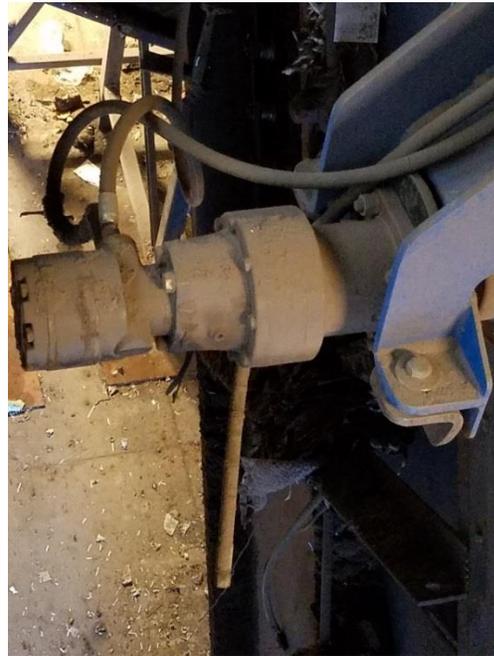
Ref A4, A10

- Loose hydraulic lines and leaking hydraulic power pack
- Worn drum and cleats
- Wrappings on drum shafts

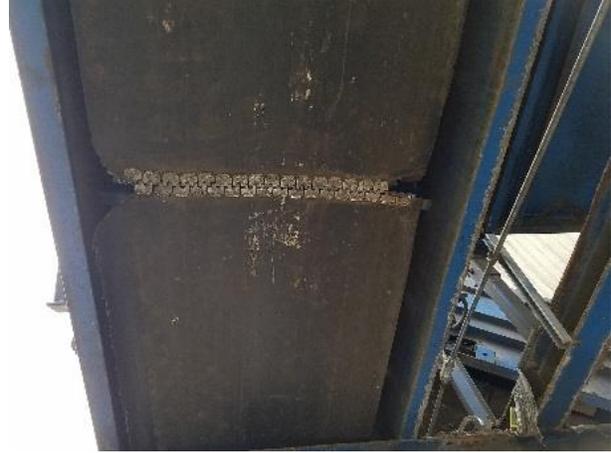
Ref A2, A5

- Bent head pulley and wrapping on shaft
- Belt heavily worn and damaged lacing
- Return Rollers missing

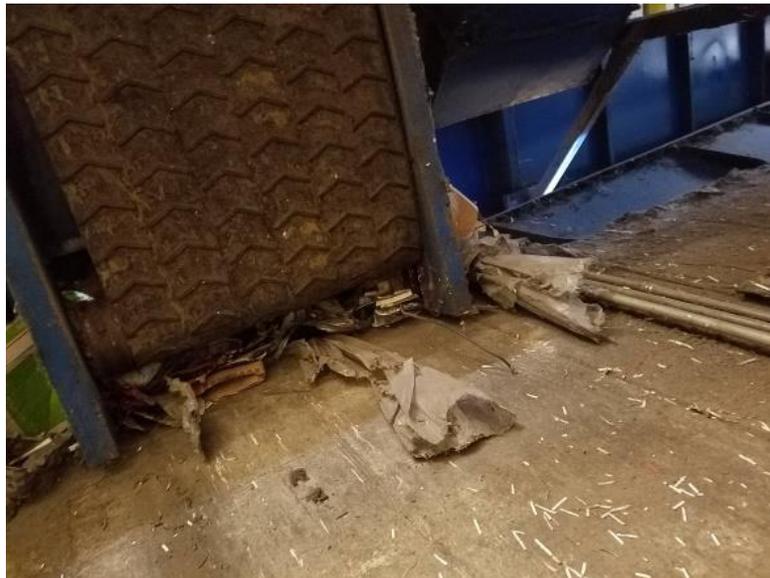
Ref A3, A5, A6

- Wrapping on head pulley
- Gearbox possibly leaking
- Belt not tracked and cutting sideboard

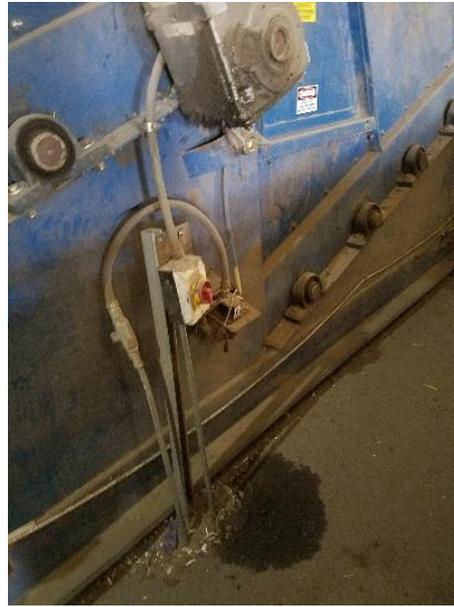
Ref A4, A14

- Bearing bolt missing
- Gearbox leaking
- Oil reservoir missing/broken
- Motor fan cover missing screw
- Motor seal-tight damaged
- Teeth on Discs heavily worn
- Transfer plate at Infeed worn thru
- Additional Fall Protection needed on right side ladder (overlooking Tip Area)

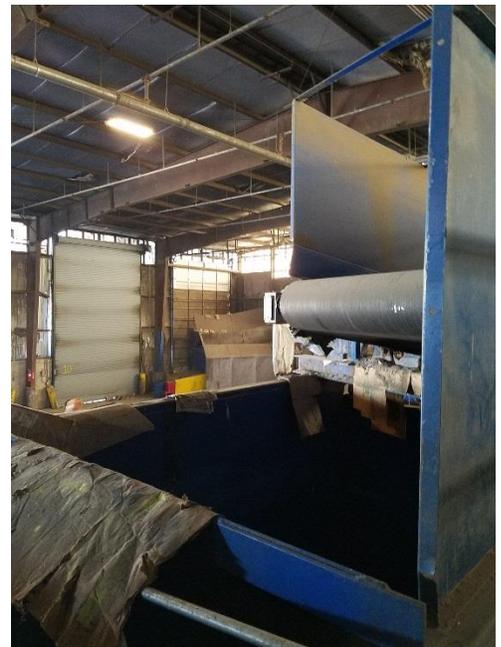
Ref A6

- Bent/Leaning support
- Bolted connection incomplete
- Missing/Worn Return Rollers
- Add Right-side Transition Plate to Contain Material

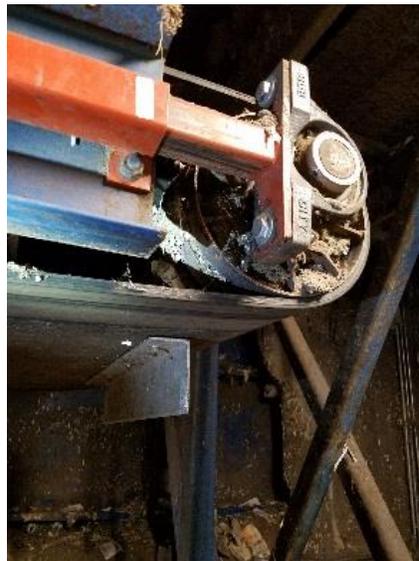
Ref A3, A8, A10

- Belly Guards missing
- Self-cleaning Tail Pulley packed with material
- Windings on tail shaft
- Return Rollers worn
- Feed chute packed with material and worn
- Upturn Return Roller missing from radius

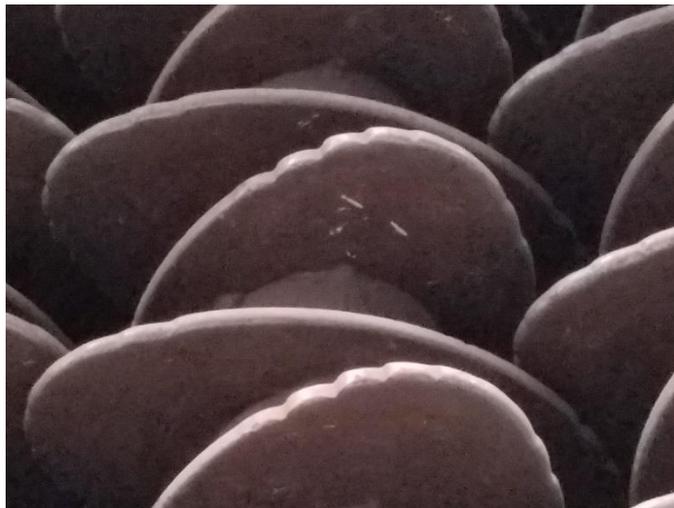
Ref A2

- Leaking Drive Motor
- Bent Handrail adjacent
- Heavily worn discs

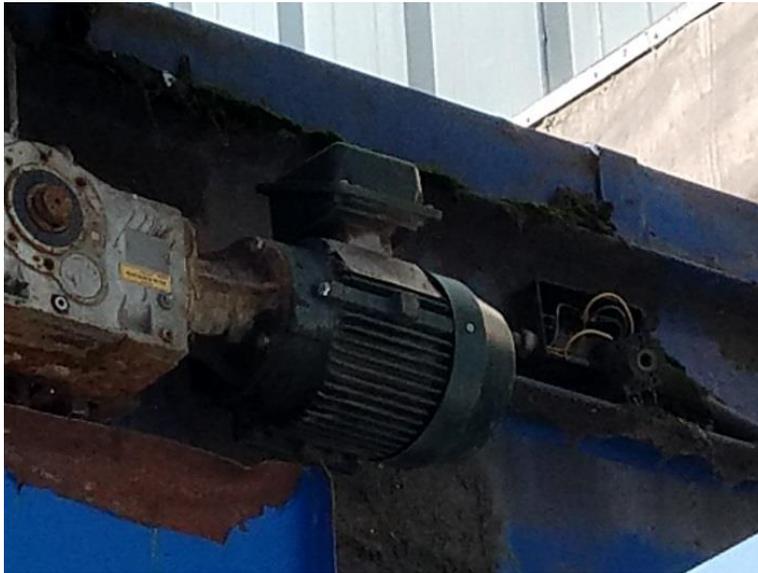
Ref A10, A14

- Open Electrical Box
- Return Roller buildup

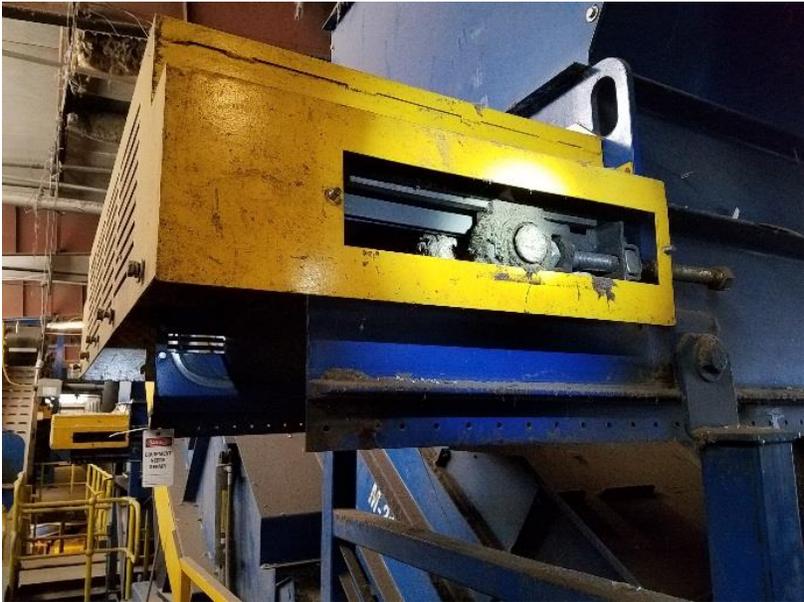
Ref A8, A10

- Belt edge torn
- Wrapping on Return Roller
- Tail Bearing Guard missing
- Missing Belly Pan at Tail
- Bearings worn
- Tail Shaft worn

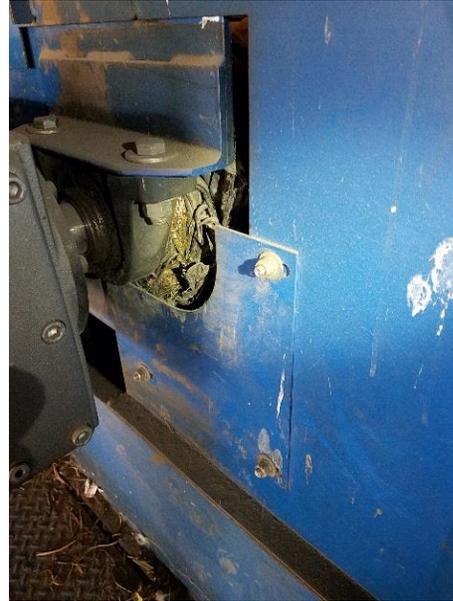
Ref A3

- Belt torn along edge
- Wrappings on Head Pulley
- Missing Belly Guard

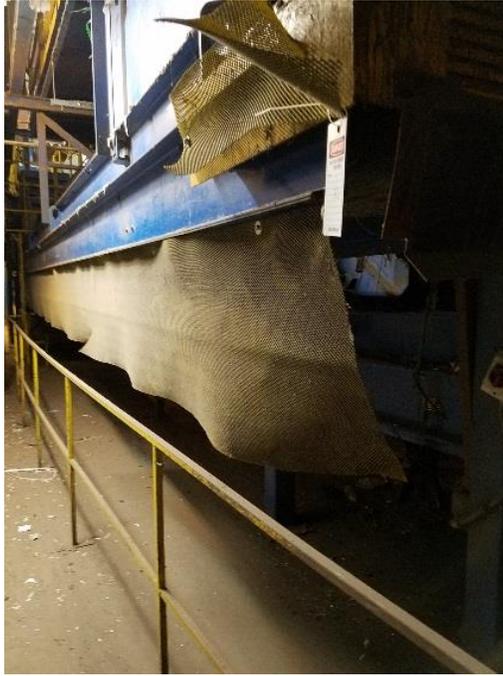
Ref A8

- Questionable guarding material
- Buildup on Return Rollers

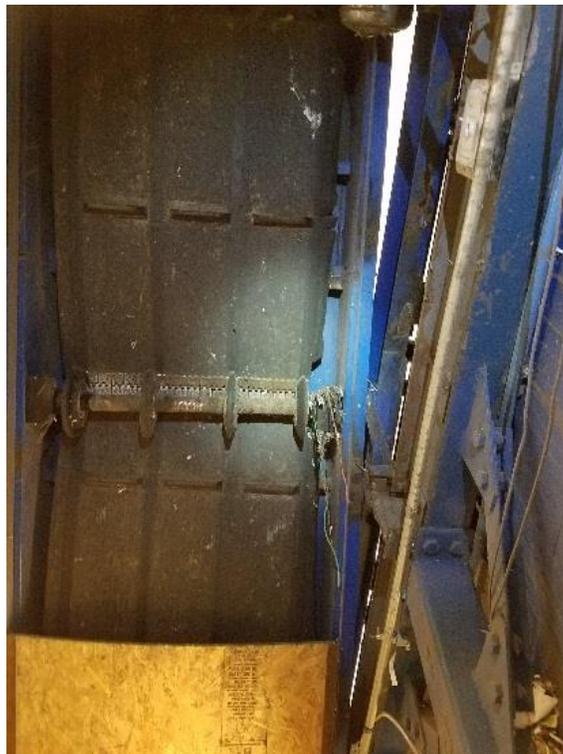
Ref A2, A3

- Belly Pan Spacing to be closed
- Worn Return Rollers and belting

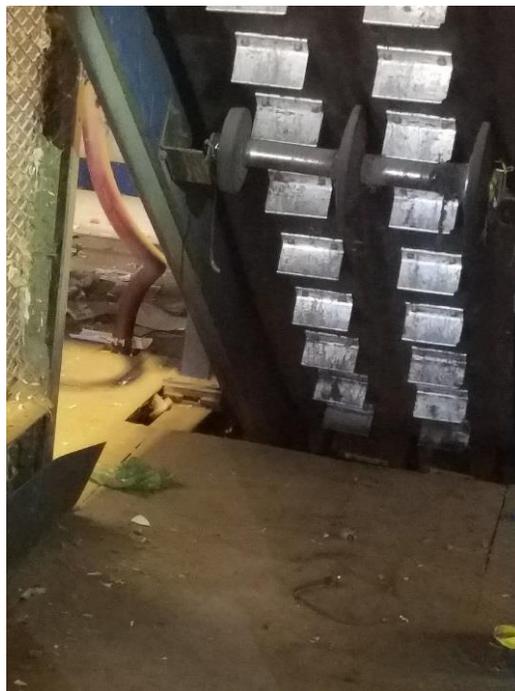
Ref A8

- Heavily worn Return Roller
- Insufficient Guarding where conveyor comes thru platform

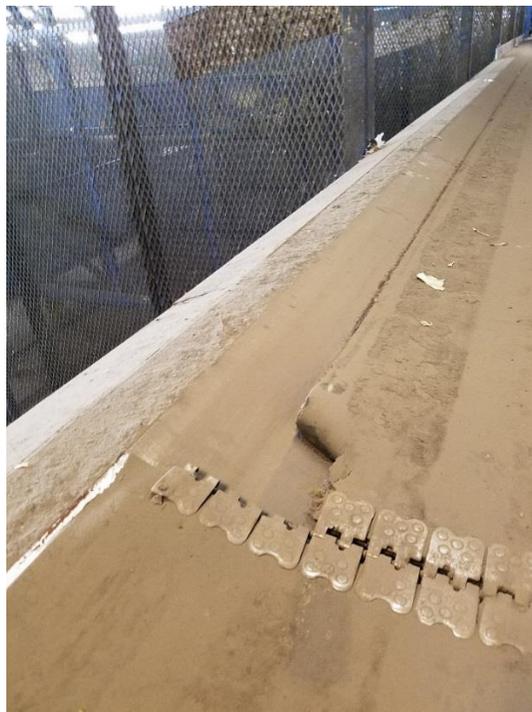
Ref A5

- Missing Belly Guard
- Missing Return Roller, others ground flat
- Torn Belting at lace and shredded edge

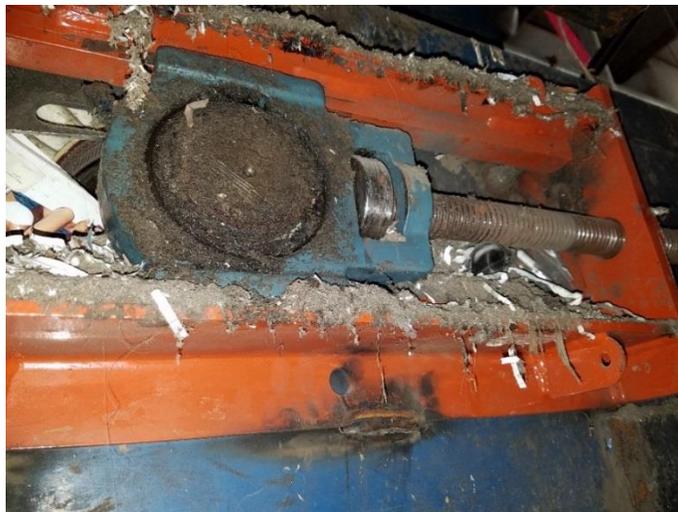
Ref A3, A8, A10

- Missing one (1) Drive Belt
- Missing Bearing Cover

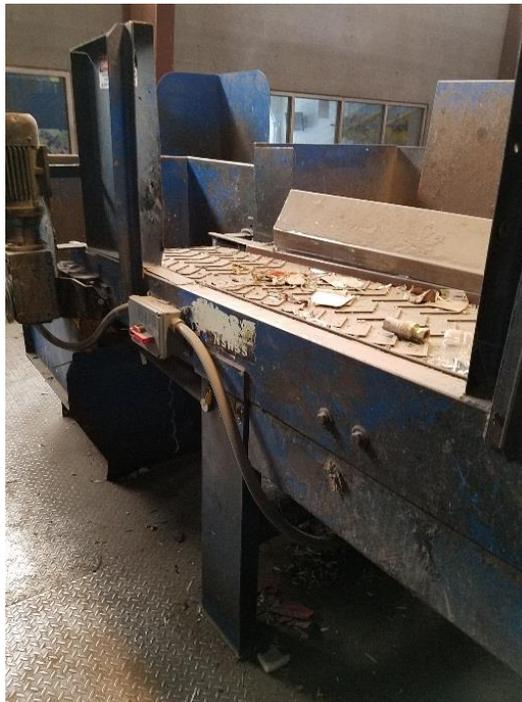
Ref A8, A12

- Belt torn at lace
- Missing Return Rollers
- Missing Belly Guard
- No E-Stop at Sort Station

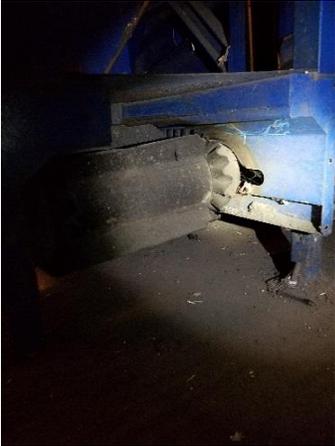
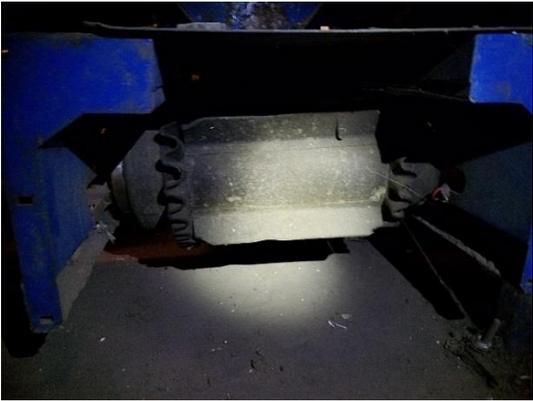
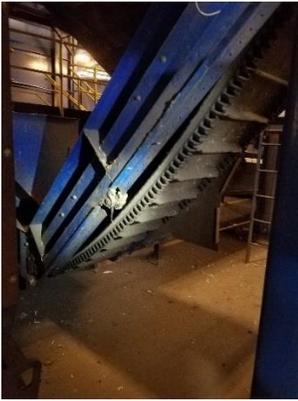
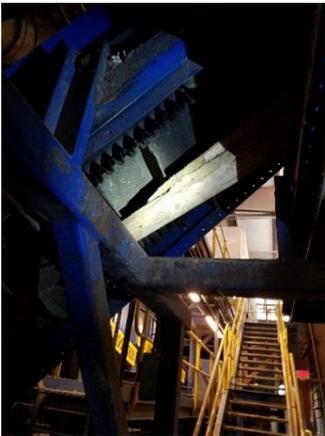
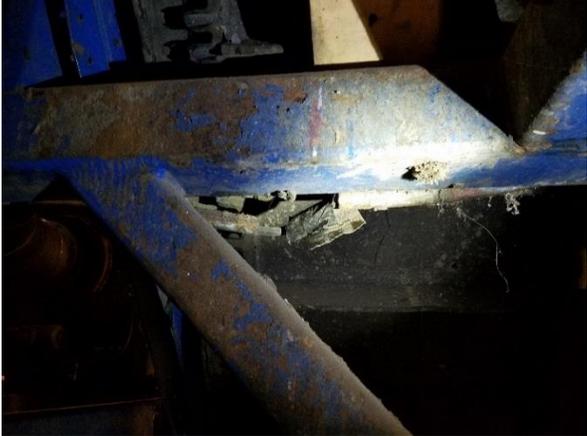
- Tail Pulley wearing thru take-up
- Belt heavily worn
- Missing Tail Guard
- Belt Return Roller Jammed & Bypassed
- Wood used to hold up belting
- Broken electrical conduit

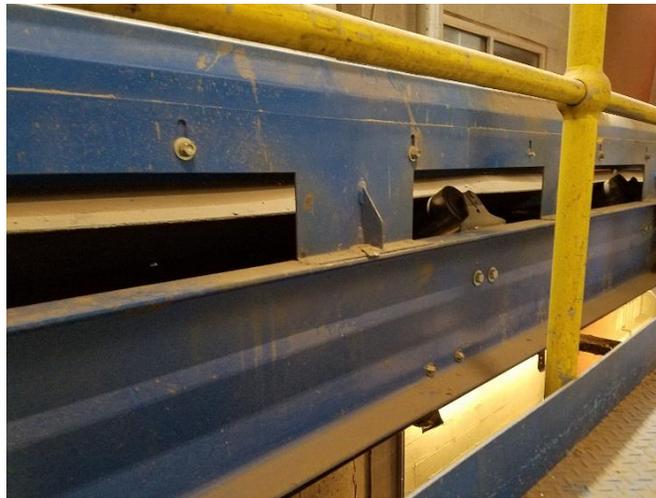
Ref A8

- Torn Belting
- Missing Tail Guard
- Missing Idler guards
